**Guidebook for the Proper Installation of Tactile  
Ground Surface Indicators (Braille Blocks):  
Common Installation Errors**

**International Association of Traffic and Safety Sciences**

**April / 2008**

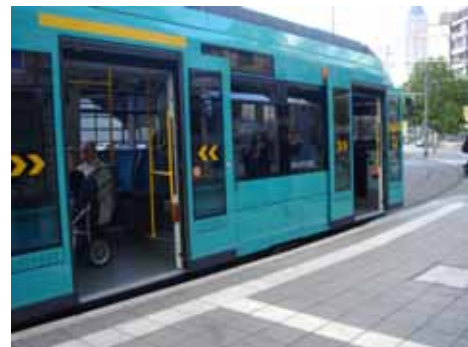
Fig. 8: Directional Blocks Used at Rail Stations (Frankfurt, Germany)

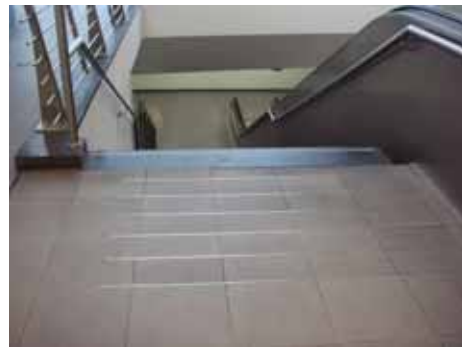
Fig. 10: Metal Disks Used in Belgium  
(Brussels, Belgium)

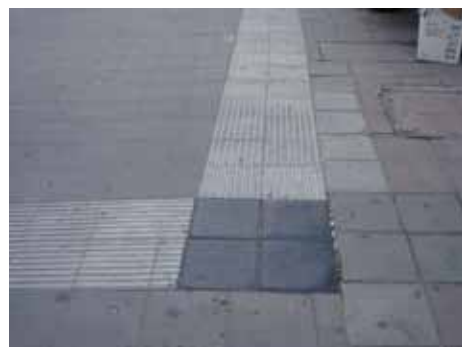
Fig. 12: Embedded Directional Metal Bars  
(Brussels, Belgium)

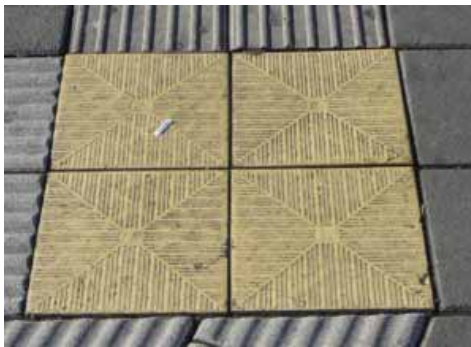
Fig. 14: Netherlands-Style Warning Blocks  
(Amsterdam, Netherlands)

Netherlands-specific blocks include some with thin recessed lines as in Fig. 14. With very little surface irregularity, such blocks are extremely difficult to detect with the feet or a white cane. Grooves carved into the pavement at subway station platforms (Fig. 15) are also difficult for people with impaired vision to recognize.

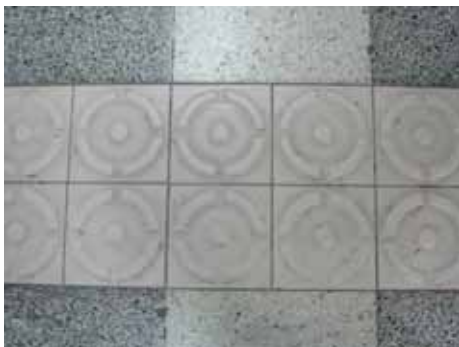
Fig. 19: Blocks Used in Some Seoul Subway Stations (Seoul, Korea)

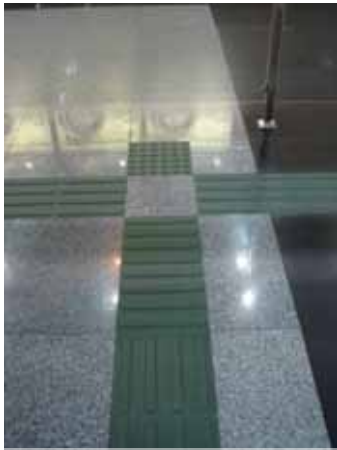
Fig. 20: No Blocks Used Where Directional Blocks Intersect (Guangzhou, China)

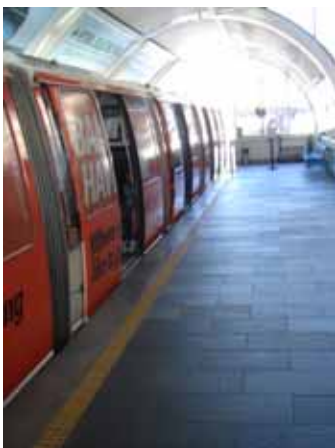
Fig. 25: Use of Narrow (15cm Wide) Warning  
Blocks (Sydney, Australia)

Examples of narrow warning blocks were observed in the UK, Australia, Korea and Taiwan. Such installations at station platforms, as in Fig. 25, can lead a person with impaired vision to fall onto the track.

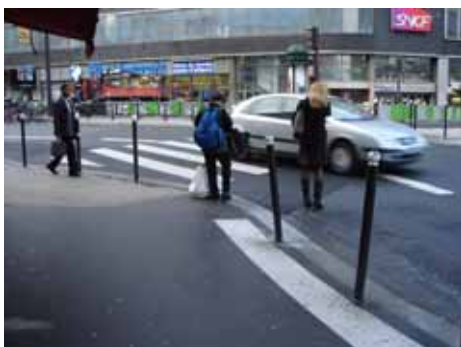
Fig. 26: Incorrect Positioning at the Entrance to a Crosswalk (Paris, France)

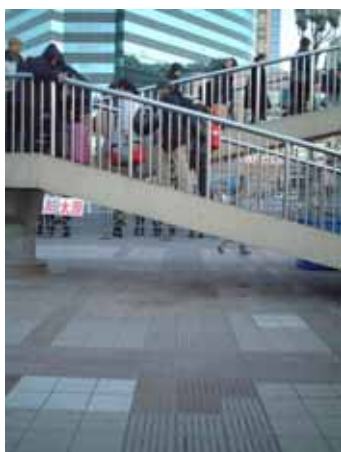
Fig. 28: Pedestrian Bridge Located above Tactile Ground Surface Indicators (Beijing, China)

Examples of obstacles above or near directional blocks (other than items such as bicycles or motorcycles that can be moved) were observed in Germany, Korea, China, Malaysia and Thailand. Because objects located above waist level cannot be detected with a white cane<sup>6</sup>, in a situation like the one illustrated in Fig. 28 a person with impaired vision could fail to notice the pedestrian bridge and crash into it, suffering serious injury.

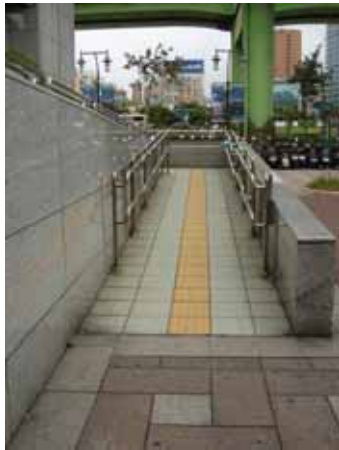
Fig. 32: Tactile Ground Surface Indicators Installed on a Slope (Taipei, Taiwan)

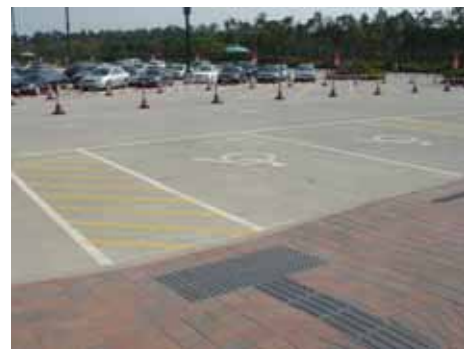
Fig. 33: Tactile Ground Surface Indicators Installed at Disabled Parking Spaces (Hong Kong)

Examples of installations at disabled parking spaces were observed in the USA and Hong Kong (Fig. 33). People with impaired vision do not use such parking spaces by themselves so blocks that impede the movement of wheelchair users should not be installed.

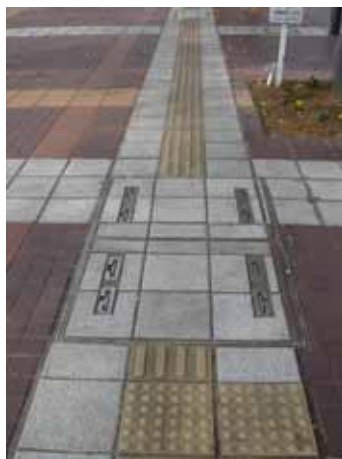
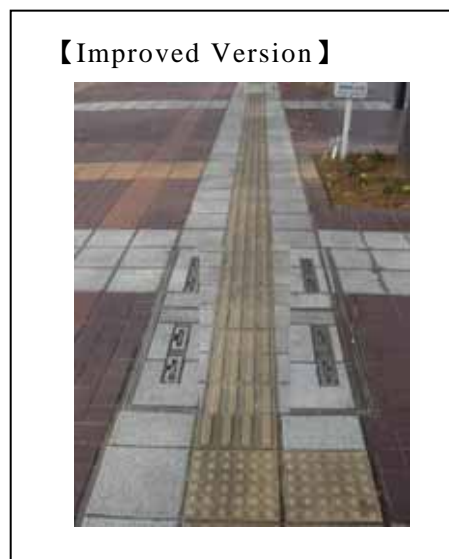
Fig. 34: As in this instance, manhole covers often interrupt the flow of directional blocks, causing people with impaired vision to lose track of which direction they should proceed.  
( Tokyo, Japan )

Improved Version: As illustrated here, manhole covers should be outfitted with Tactile ground surface indicators.

Directional blocks must be installed in succession or people with impaired vision will be required to search for the next block using their canes, greatly reducing their walking efficiency. Manhole covers are one cause of such discontinuity and should generally be outfitted with Tactile ground Surface Indicators.

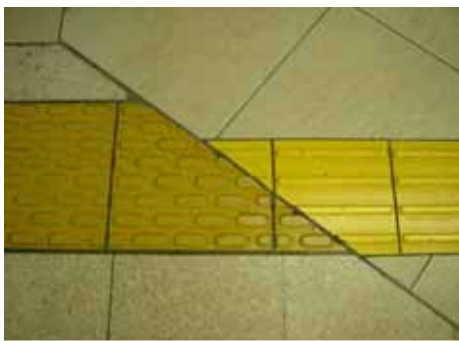
Fig. 38: The situation depicted here is the result of different organizations having jurisdiction over the areas to the left and the right. Both types of blocks are directional blocks but the ones on the left with raised ovals can easily be mistaken for warning blocks with raised dots. The likelihood of misreading the blocks is particularly high when walking from the right to the left. ( Tokyo, Japan )

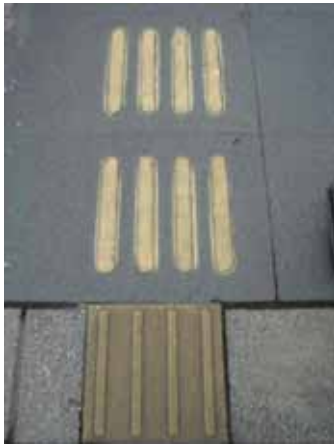
Fig. 40: Many examples of similar errors can also be found overseas. (Taipei, Taiwan)

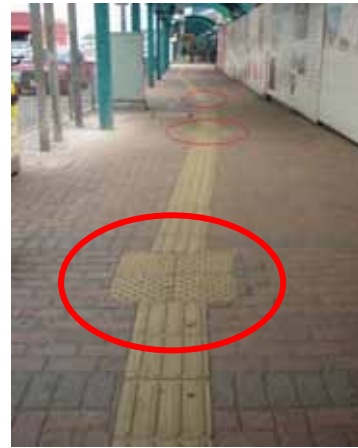
Fig. 43: Many similar examples of the overuse of warning blocks can also be found overseas. (Hong Kong)

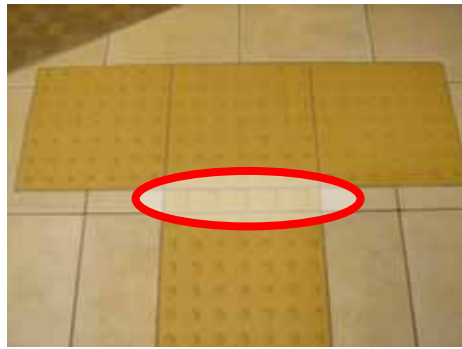
Fig. 46: A directional block of but 5cm width sandwiched between warning blocks, as pictured here, will go unnoticed by people with impaired vision. ( Tokyo, Japan )

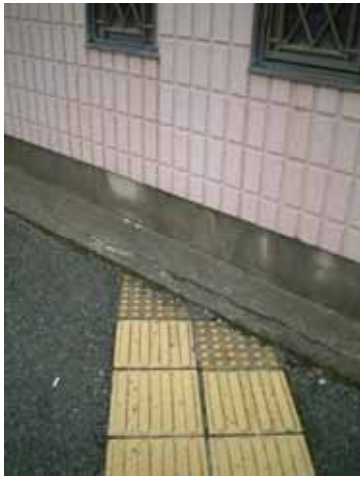
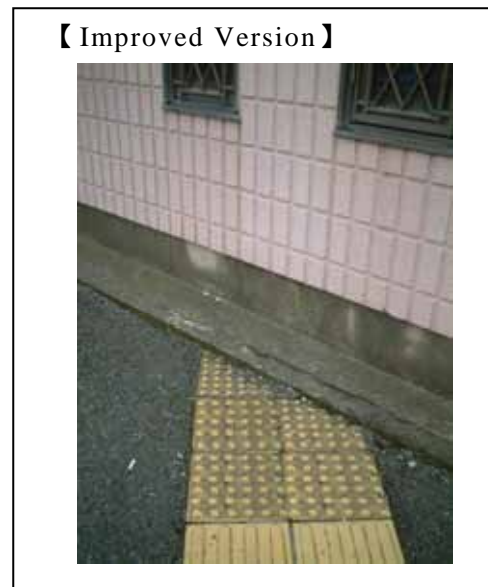
Fig. 48: Because of the small area covered by the warning blocks installed before the wall, people with impaired vision will run into the wall before noticing the warning blocks. ( Kanagawa, Japan )

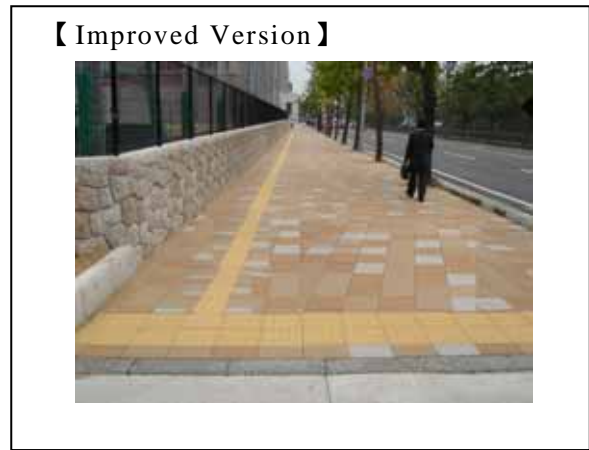
Fig. 50: This is an example of an unnecessary bend in a directional block installation preceding a crosswalk. The directional blocks should simply continue straight ahead as in the improved version. ( Wakayama, Japan )

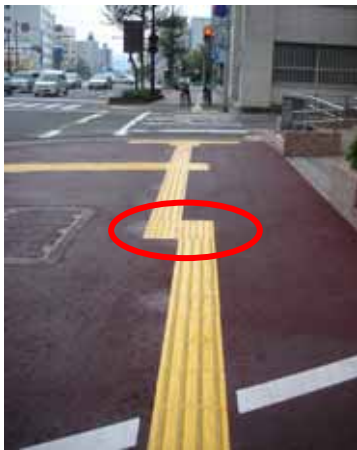
Fig. 51: Here, warning blocks have been installed where the row of directional blocks was shifted over to the left by the width of one block (30cm) before a crosswalk to align the directional blocks with the center of the crosswalk. As long as the directional blocks leading to a crosswalk are not too close to the crosswalk's edge, there is no need to install warning blocks and alter the course of the directional blocks in this way. ( Hokkaido, Japan )

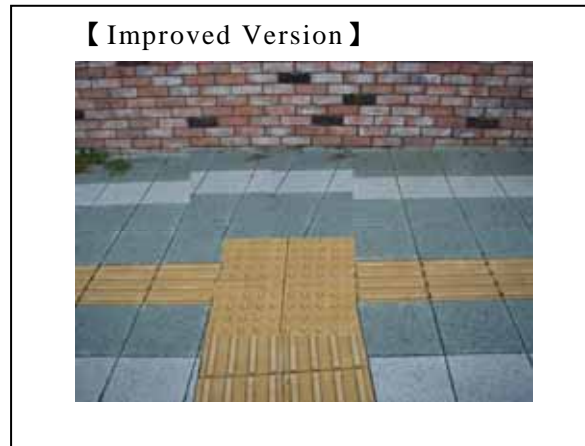
Fig. 53: Here, a single row of directional blocks leads to the wall followed by warning blocks signaling the end of the line. These blocks are unnecessary. As in the improved version, the warning blocks signaling the intersection alone are sufficient. ( Wakayama, Japan )

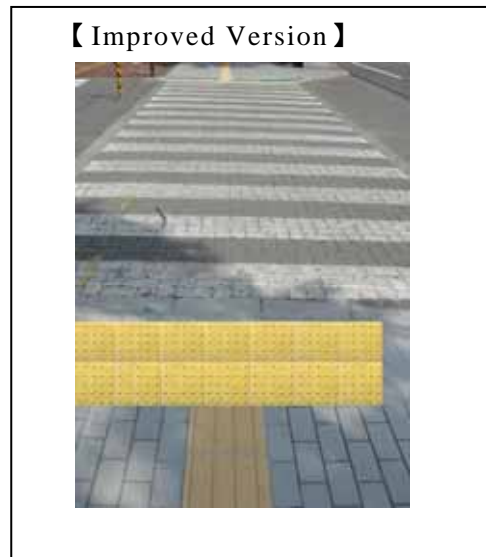
Fig. 54: Situations like this one are extremely dangerous as people with impaired vision, rather than stopping before the crosswalk, will step out into traffic as they search for the continuation of the line of directional blocks. Warning blocks should be installed as in the improved version. ( Hokkaido, Japan )

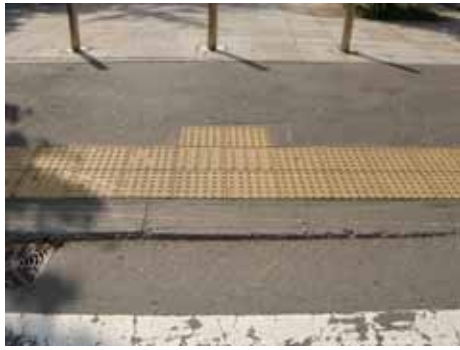
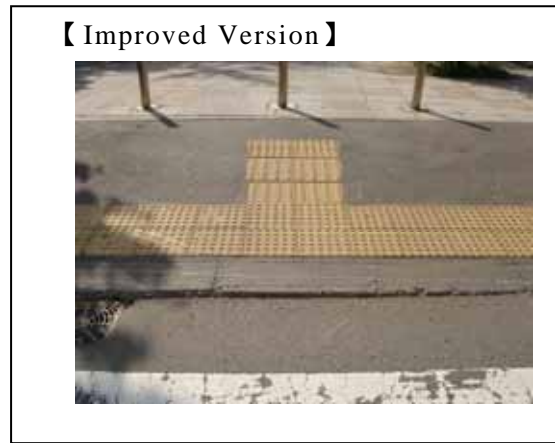
Fig. 55: It is ordinarily best to install two rows of warning blocks before a crosswalk. Where directional blocks are followed by only a single row of warning blocks, as shown here, people with impaired vision may either fail to notice the warning blocks and walk out into the road or inadvertently step over the warning blocks and come to a stop after stepping out into the road. Two rows of warning blocks should be installed as in the improved version. ( Hokkaido, Japan )

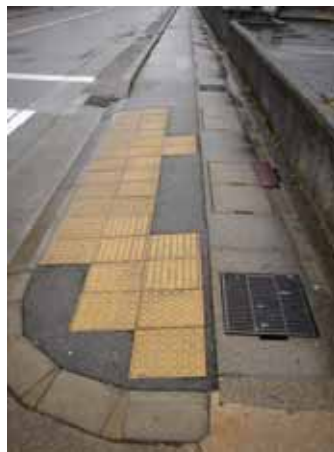
Fig.56: On narrow sidewalks like this, one sometimes sees installations where many Tactile ground surface indicators are used to mark crosswalks leading in two directions, making it difficult for people with impaired vision to determine where the blocks lead and what they are meant to warn them of. In situations like this, despite the general rule of using two rows of warning blocks before crosswalks, the number of blocks should be adjusted as needed to prioritize ease of identification by users. The improved version makes it easier to determine the position and orientation of the crosswalks by using single rows of warning blocks that are installed to completely cover the edges of the sidewalk. (Ishikawa, Japan)

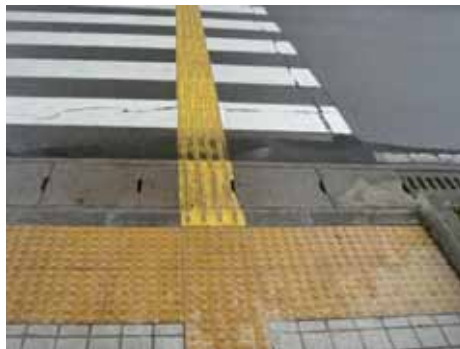
Fig. 57: Directional blocks are increasingly installed within crosswalks, something extremely effective for people with impaired vision. When crossing the road, people with impaired vision try to be particularly careful not to proceed in the wrong direction. Should they stray greatly from the intended path they may be unable to reach the far side of the road and instead stray into the road. However, using blocks of the same shape as ordinary directional blocks, as in this example, is dangerous because users may not realize they are in a crosswalk. Specially shaped blocks such as those shown in Fig. 58 should be used in crosswalks. (Miyazaki, Japan)

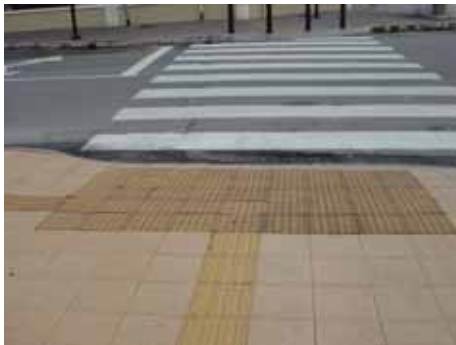
Fig. 61: Examples of numerous Tactile ground surface indicators installed before crosswalks, which can cause people with impaired vision to lose their way, are often seen overseas as well as in Japan. (Kuala Lumpur, Malaysia)

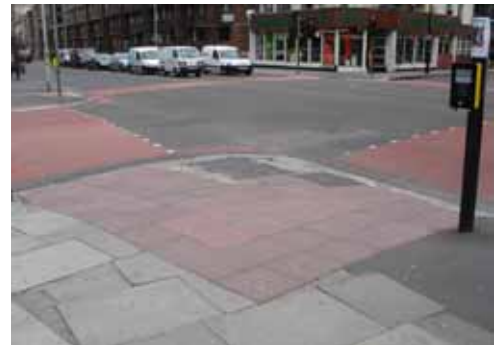
Fig. 62: Covering the sidewalk with blocks as in this example makes it impossible for users to determine where the crosswalks are or which direction to proceed. (London, UK)

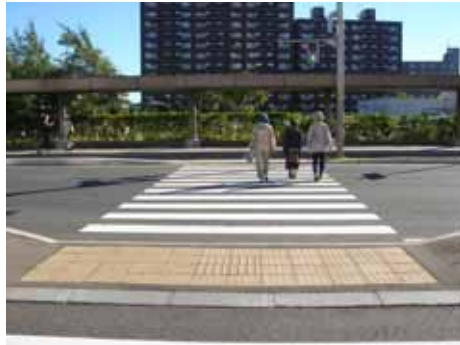
Fig. 63: Wide medians like this one can cause people with impaired vision to mistakenly think they have crossed the road, so blocks need to be installed in accordance with the proper rules. Blocks installed over the entire surface, as is the case here, are cause for user confusion. Accordingly, installations should be consistent in using double rows of warning blocks at either end of the crosswalk and single rows of warning blocks on either side of the median. ( Hokkaido, Japan )

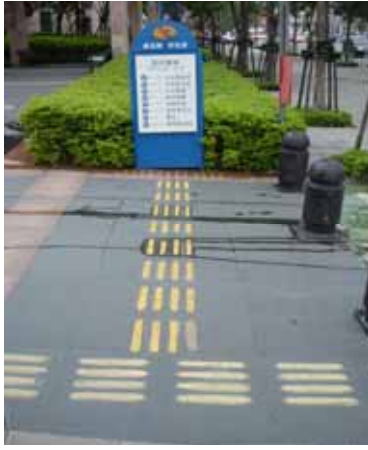
Fig. 66: Similar errors are also common overseas. (Taipei, Taiwan)

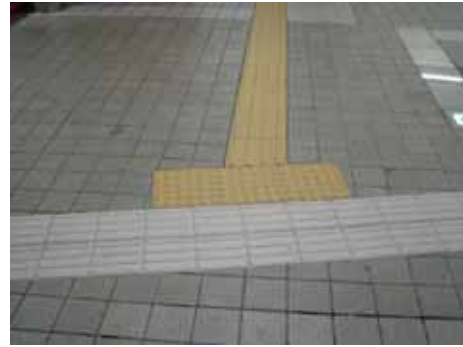
Fig. 67: Warning blocks are sometimes installed in this manner at T-shaped intersections, but such warning blocks will go unnoticed by people with impaired vision who are moving along the path composed of white directional blocks. (Seoul, Korea)

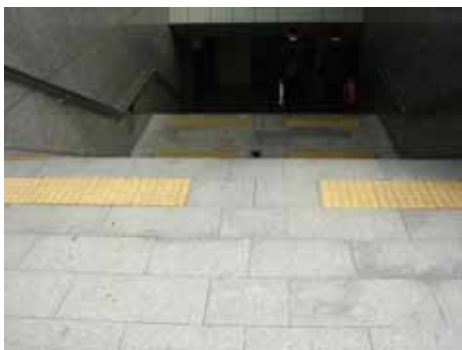
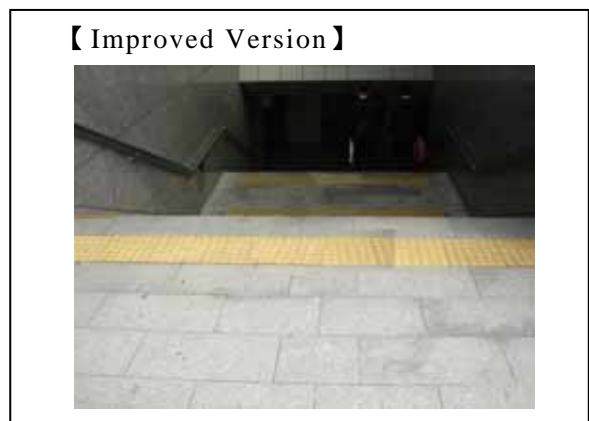
Fig. 68: Here, the line of warning blocks installed at the top of the stairs is truncated. A person with impaired vision arriving at the open gap would fail to come to a stop as there are no warning blocks. There is a real danger of falling down the stairs. The line of warning blocks should be continuous as in the improved version. ( Toyama, Japan )

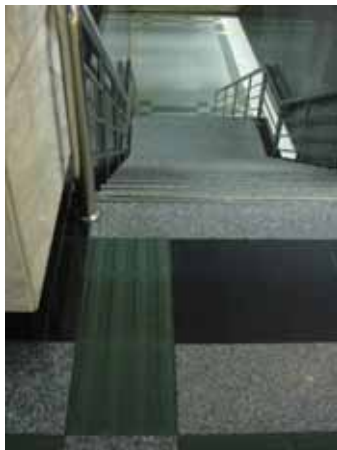
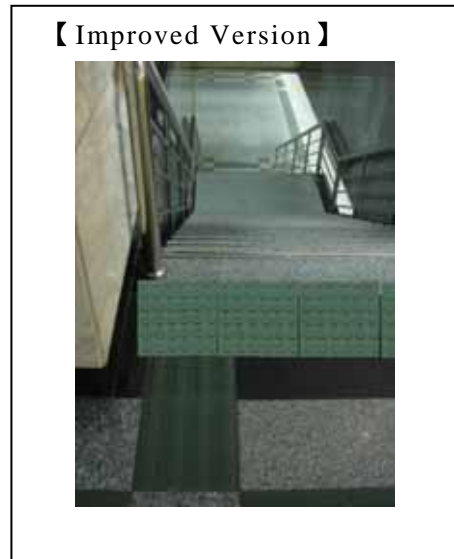
Fig. 69: Here there are no warning blocks at the top of the stairs. Unable to stop, people with impaired vision may fall down the stairs. (Guangzhou, China)

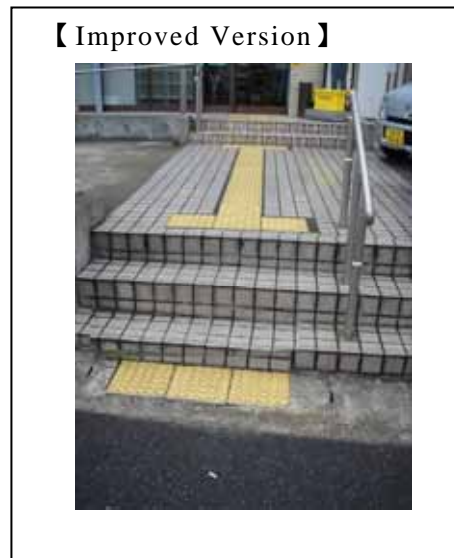
Fig. 70: Warning blocks should generally be installed at the top of stairways and on the ground or floor following the final step. Here, the warning blocks at the bottom of the stairs have been installed not on the ground level but on the final step. People with impaired vision coming down the stairs will sense the warning blocks and determine that they have reached ground level. Because in fact they have an additional step to go, this may lead to accidents such as falls or twisted ankles. Warning blocks should be repositioned as in the improved version. ( Aichi, Japan )

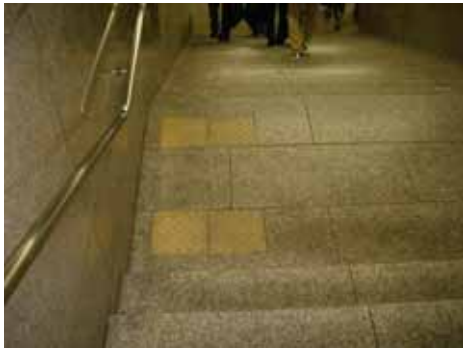
Fig. 74: In general, single rows of warning blocks should be installed at the beginning and end of stair landings. It is inappropriate to install them only near handrails rather than across the entire width of the stairs, as shown here. The elderly are the primary users of handrails at rail stations. Because of the danger of collision with the elderly, many people with impaired vision do not use handrails when ascending and descending stairs. ( Osaka, Japan )

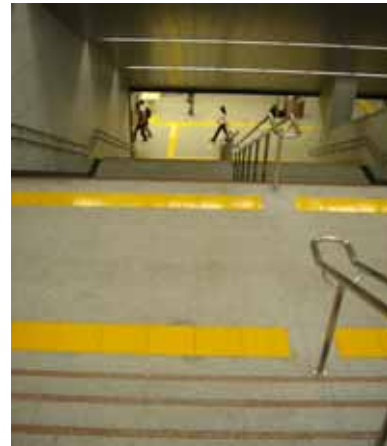
Fig. 75: Warning blocks should be installed across the entire width of the stairway, as shown here. The one-block interruption at the center of the rows of warning blocks is due to the position of the handrail. ( Ibaraki, Japan )

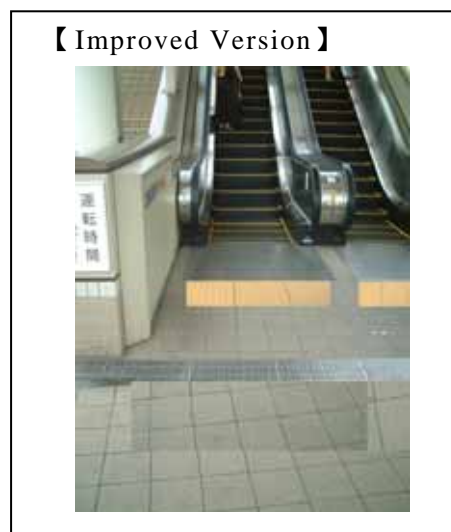
Fig. 76: Here the warning blocks are located too far from the entrance to the escalator, and should instead be installed as in the improved version. ( Tokyo, Japan )

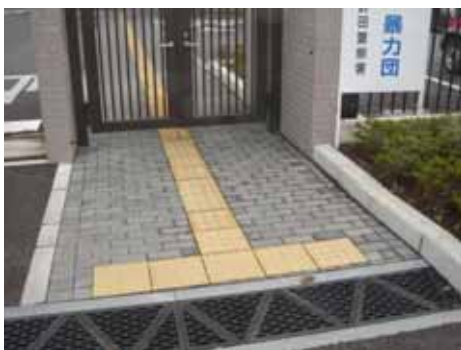
Fig. 78: Warning blocks should be installed before gates. ( Chiba, Japan )

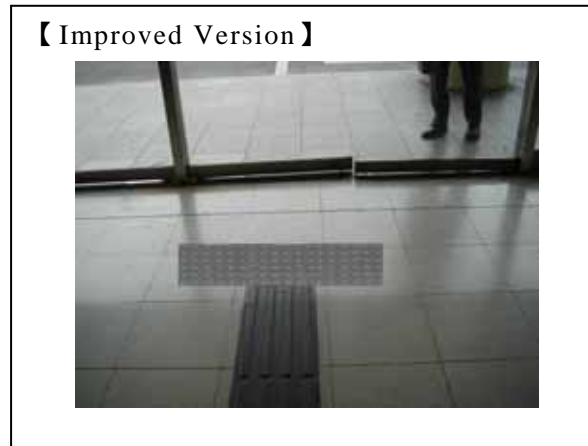
Fig. 79: Here a line of directional blocks ends without warning blocks before a door. Because people with impaired vision will continue toward the door without stopping, there is the risk that they could hit their head on the edge of the door should it happen to be open. Warning blocks should be installed as in the improved version. ( Osaka, Japan )

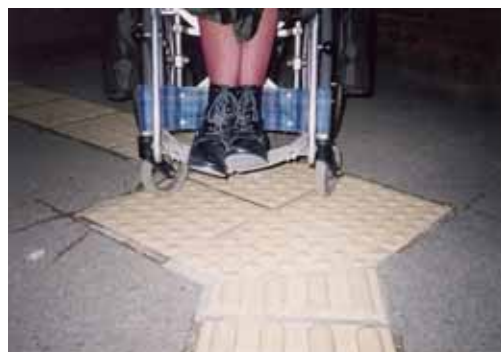
Fig. 80: As depicted here, the protrusions on Tactile ground surface indicators can cause wheelchair wheels to change direction, making it difficult to move forward.

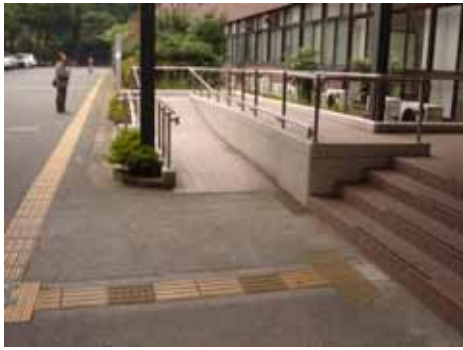
Fig. 81: As shown here, directing people with impaired vision to use the stairs instead of installing Tactile ground surface indicators on the slope eliminates the problem of inconvenience for wheelchair users. ( Tokyo, Japan )

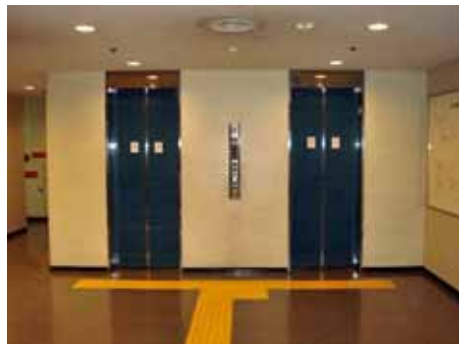
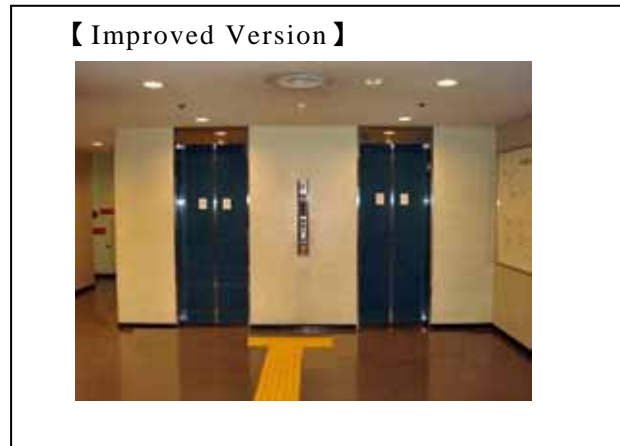
Fig. 85: Tactile ground surface indicators installed in this way create a barrier for wheelchair users. Blocks should instead be installed only before the call buttons as shown in the improved version. ( Osaka, Japan )

Tactile ground surface indicators installed in front of elevator entrances can cause wheelchair wheels to catch. Therefore, care must be taken to minimize the barrier to wheelchair use by installing Tactile ground surface indicators only before the call buttons rather than across the entire width of the elevator entrance.

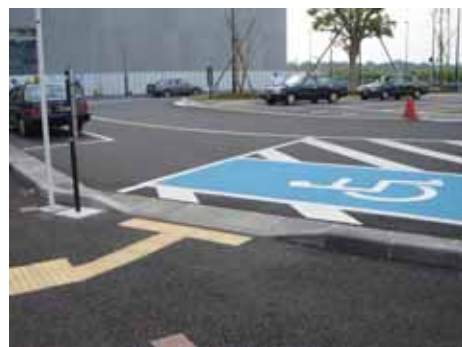
Fig. 90: Because disabled parking spaces are established primarily for wheelchair users, Tactile ground surface indicators should not be installed. ( Chiba, Japan )

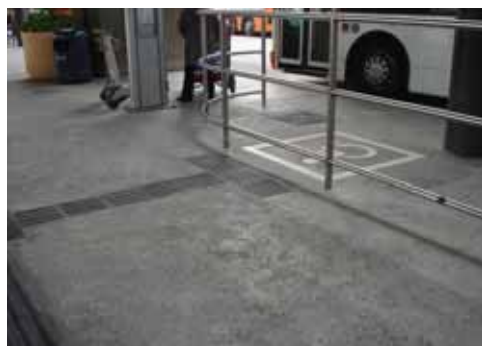
Fig. 93: Here it is impossible to follow the Tactile ground surface indicators to the bus stop due to fencing that was installed later. (Hong Kong)

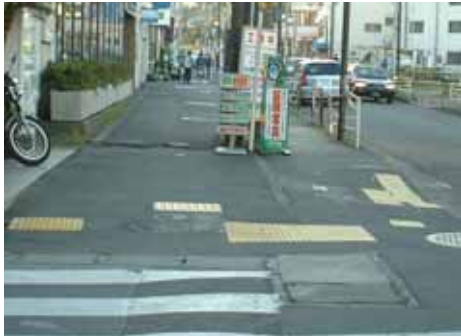
Fig. 94: Because the Tactile ground surface indicators have peeled away before the crosswalk, people with impaired vision may not recognize that there is a crosswalk and step out into the road. ( Kanagawa, Japan )

One often sees cases where blocks have come loose or are broken and scattered about because regular maintenance has not been conducted after installation. This not only defeats the purpose of having Tactile ground surface indicators at all but also poses a tripping risk for pedestrians and looks terrible.

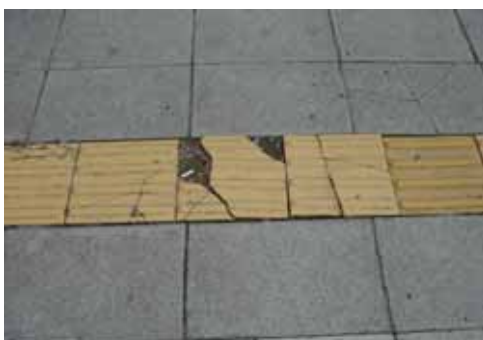
Fig. 96: An example of broken blocks left unattended. (Seoul, Korea)

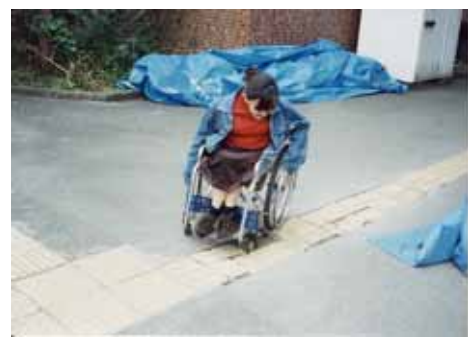
Fig. 97: Broken blocks not only pose a danger to people with impaired vision but are also a major barrier for wheelchair users.

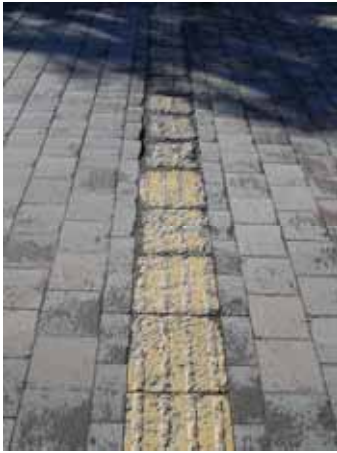
Fig. 98: In snowy areas, snow removal efforts often result in the loss of many protrusions. ( Hokkaido, Japan )

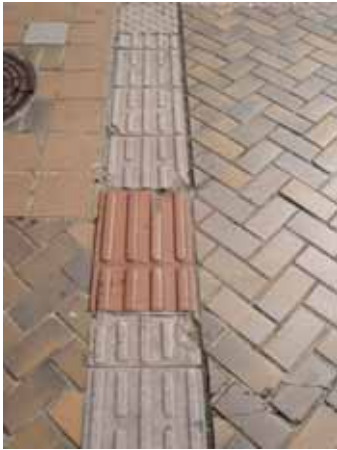
Fig. 99: The use of blocks different than those originally installed is common when Tactile ground surface indicators are repaired. The resulting mix of different specifications and shapes can lead to confusion among people with impaired vision. The loss of visual consistency is also unattractive. ( Fukuoka, Japan )

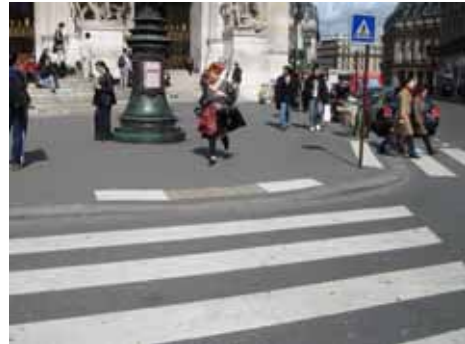
Fig. 100: This photograph, taken before the Paris Opera House, shows the unattractive result of repair using a different type of blocks than those originally used. (Paris, France)

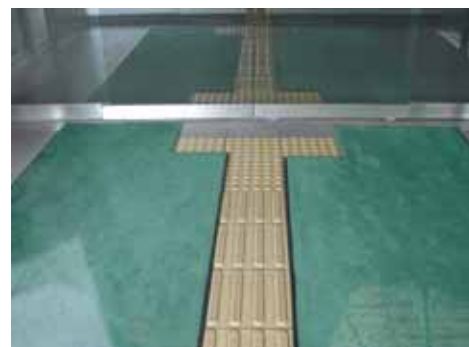
Fig. 105: Rather than cover the Tactile ground surface indicators with the mats, the mats should be shaped as shown to leave the blocks uncovered. ( Hiroshima, Japan )

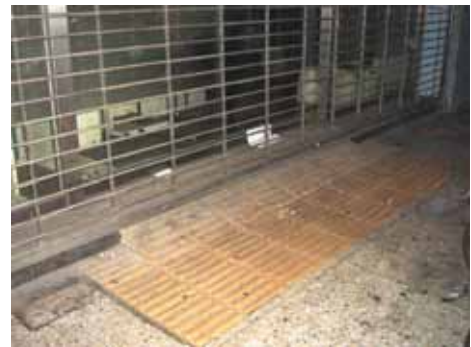
Fig. 108: Here, at the entrance to a store, Tactile ground surface indicators are used to create a non-slip surface as in Fig. 107. (Taipei, Taiwan)
