**Guidebook for the Proper Installation of Tactile
Ground Surface Indicators (Braille Blocks):
Common Installation Errors**

International Association of Traffic and Safety Sciences

April / 2008

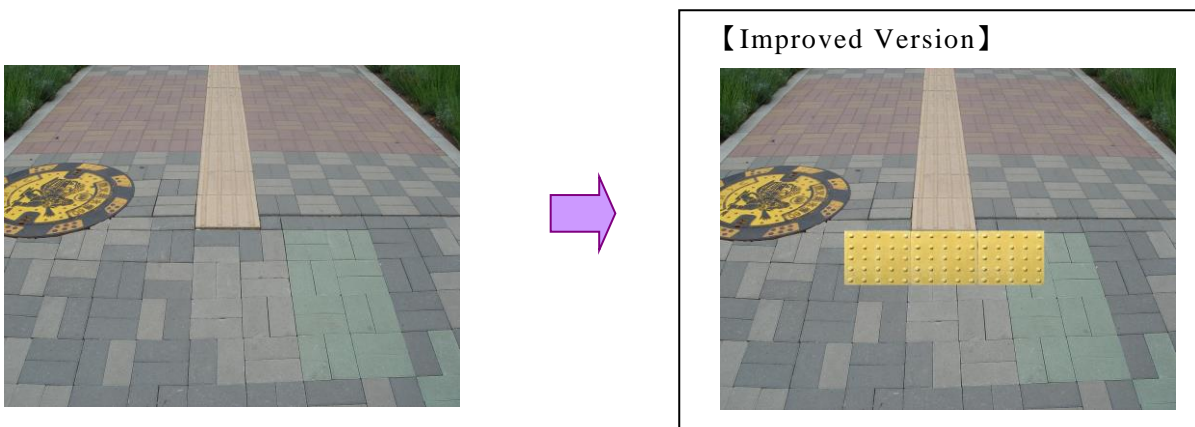
Fig. 37: Here there are no warning blocks installed at the end of a sequence of directional blocks. The suggested remedy is to clearly indicate that the line of directional blocks has ended by installing warning blocks. (Ibaraki, Japan)

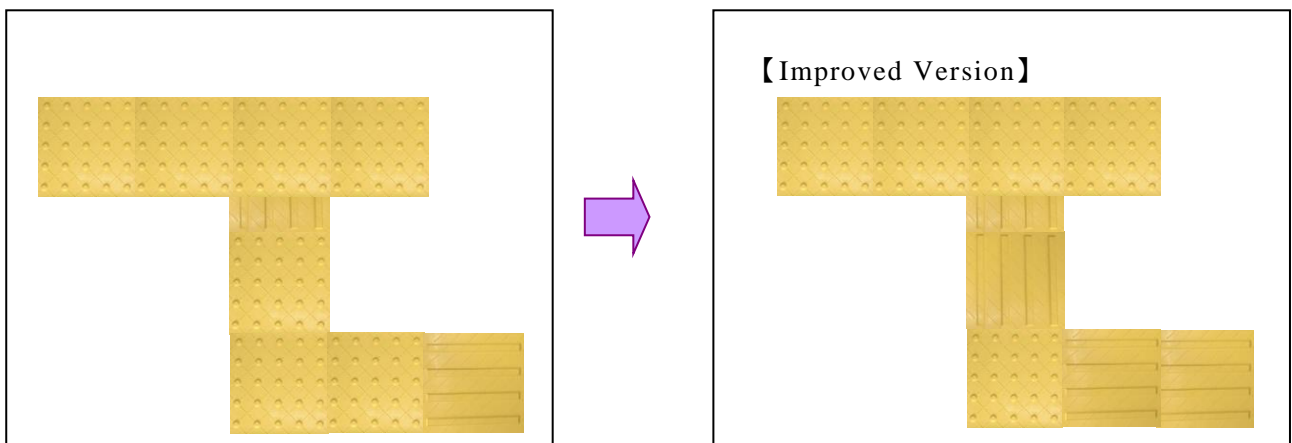
Fig. 47: In a narrow corridor where blocks must be arranged in an L-shape, one warning block should be installed at the bend in the L with directional blocks above and to the right as illustrated in the improved version here. (Tokyo, Japan)

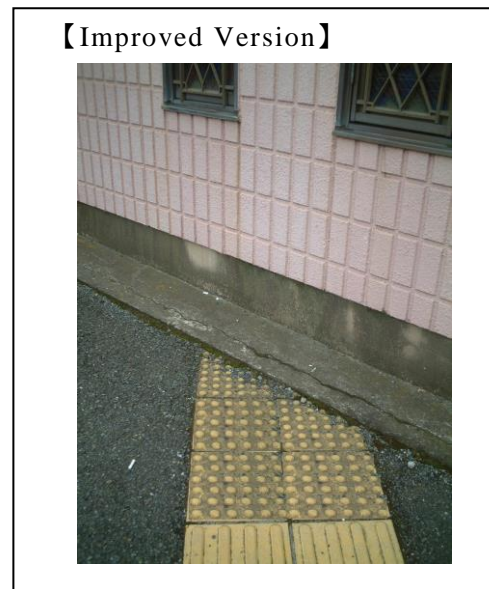
Fig. 48: Because of the small area covered by the warning blocks installed before the wall, people with impaired vision will run into the wall before noticing the warning blocks. (Kanagawa, Japan)

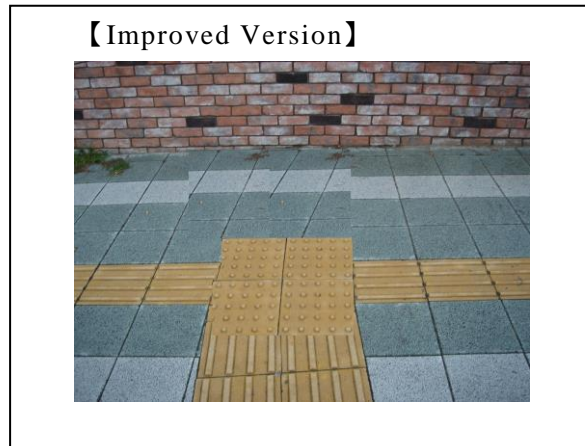
Fig. 53: Here, a single row of directional blocks leads to the wall followed by warning blocks signaling the end of the line. These blocks are unnecessary. As in the improved version, the warning blocks signaling the intersection alone are sufficient. (Wakayama, Japan)

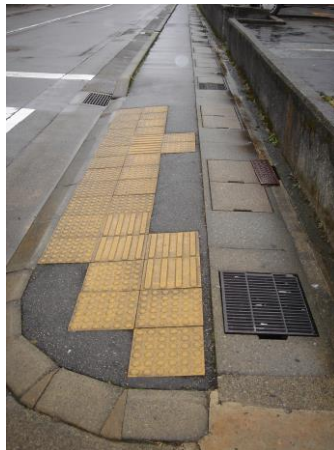
Fig.56: On narrow sidewalks like this, one sometimes sees installations where many Tactile ground surface indicators are used to mark crosswalks leading in two directions, making it difficult for people with impaired vision to determine where the blocks lead and what they are meant to warn them of. In situations like this, despite the general rule of using two rows of warning blocks before crosswalks, the number of blocks should be adjusted as needed to prioritize ease of identification by users. The improved version makes it easier to determine the position and orientation of the crosswalks by using single rows of warning blocks that are installed to completely cover the edges of the sidewalk. (Ishikawa, Japan)

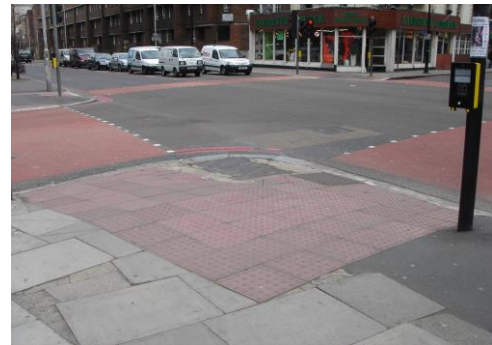
Fig. 62: Covering the sidewalk with blocks as in this example makes it impossible for users to determine where the crosswalks are or which direction to proceed. (London, UK)

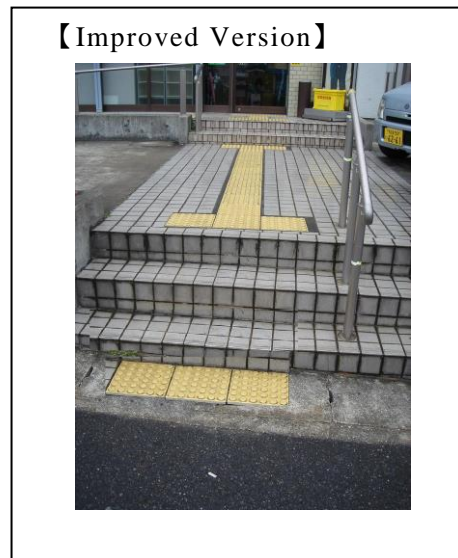
Fig. 70: Warning blocks should generally be installed at the top of stairways and on the ground or floor following the final step. Here, the warning blocks at the bottom of the stairs have been installed not on the ground level but on the final step. People with impaired vision coming down the stairs will sense the warning blocks and determine that they have reached ground level. Because in fact they have an additional step to go, this may lead to accidents such as falls or twisted ankles. Warning blocks should be repositioned as in the improved version. (Aichi, Japan)

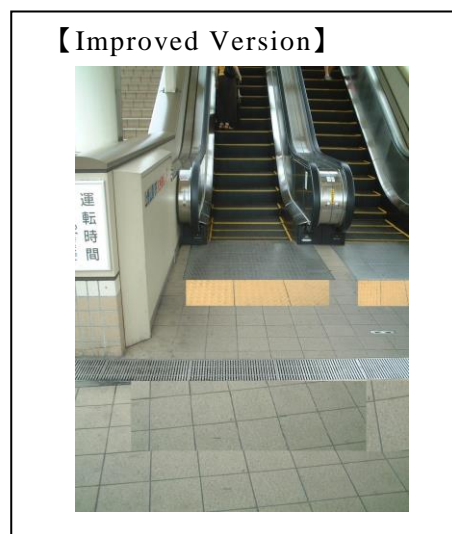
Fig. 76: Here the warning blocks are located too far from the entrance to the escalator, and should instead be installed as in the improved version. (Tokyo, Japan)

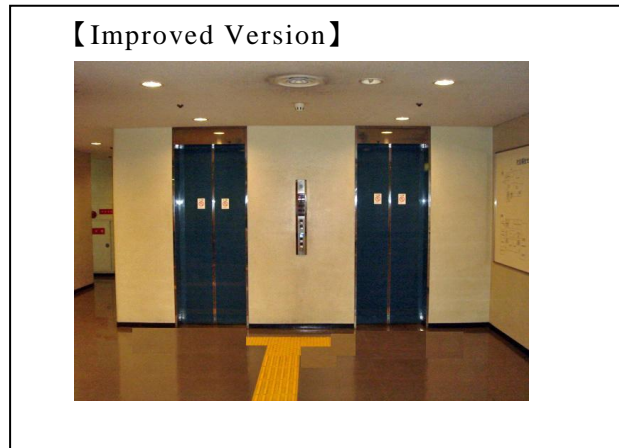
Fig. 85: Tactile ground surface indicators installed in this way create a barrier for wheelchair users. Blocks should instead be installed only before the call buttons as shown in the improved version. (Osaka, Japan)

Tactile ground surface indicators installed in front of elevator entrances can cause wheelchair wheels to catch. Therefore, care must be taken to minimize the barrier to wheelchair use by installing Tactile ground surface indicators only before the call buttons rather than across the entire width of the elevator entrance.

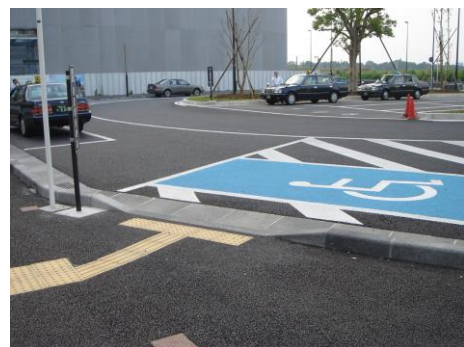
Fig. 90: Because disabled parking spaces are established primarily for wheelchair users, Tactile ground surface indicators should not be installed. (Chiba, Japan)

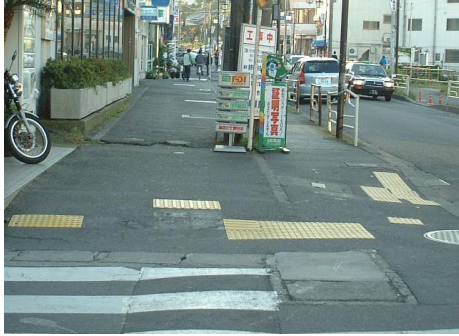
Fig. 94: Because the Tactile ground surface indicators have peeled away before the crosswalk, people with impaired vision may not recognize that there is a crosswalk and step out into the road. (Kanagawa, Japan)

One often sees cases where blocks have come loose or are broken and scattered about because regular maintenance has not been conducted after installation. This not only defeats the purpose of having Tactile ground surface indicators at all but also poses a tripping risk for pedestrians and looks terrible.

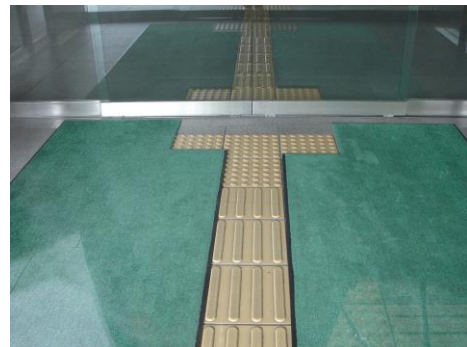
Fig. 105: Rather than cover the Tactile ground surface indicators with the mats, the mats should be shaped as shown to leave the blocks uncovered. (Hiroshima, Japan)
