**Guidebook for the Proper Installation of Tactile  
Ground Surface Indicators (Braille Blocks):  
Common Installation Errors**

**International Association of Traffic and Safety Sciences**

**April / 2008**

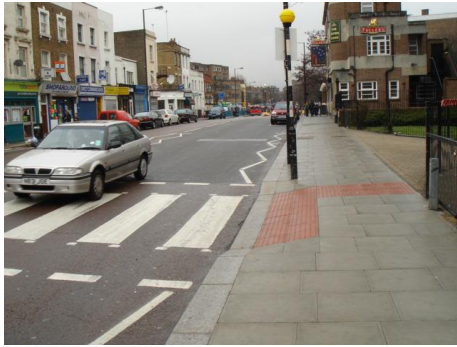
Fig. 3: L-Shaped Tactile ground surface indicator Installation (London, UK)

Blocks are mainly installed before crosswalks, at medians, at station platforms and at the top and bottom of stairways. Blocks with dots are for installations at crosswalks, medians and station platforms while blocks with bars are for installations at stairways. The color of blocks installed before crosswalks is also supposed to vary with crosswalk type: red blocks are to be used before zebra crossings (where pedestrians always have the right of way), pelican crossings (equipped with push-button traffic lights) and puffin crossings (with sensor-equipped push button traffic lights) while other colors (yellow, grey, etc.) are to be used at other crosswalks where automobiles have the right of way. The difference in color is intended to assist people with low vision navigate the crosswalk safely, but many locations do not conform to the established colors. Different color blocks are also sometimes installed when repairs are made. Blocks are installed in an L-shaped configuration at crosswalks with push-button traffic signals, with the corner of the L marking the location of the push button (Fig. 3).

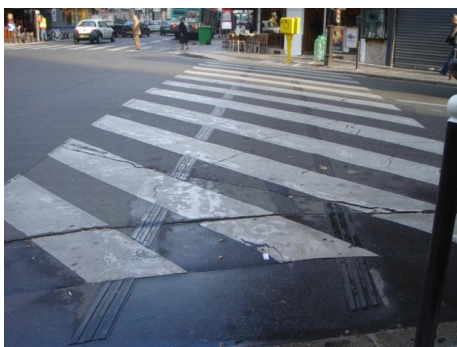
Fig. 5: Directional Blocks within a Crosswalk (Paris, France)

In Paris, warning blocks are installed before crosswalks, at the top and bottom of stairs leading in and out of subway stations and on subway and train platforms. In some areas, blocks serving a directional function are installed within crosswalks (Fig. 5). Most blocks are white but black, grey and pale yellow are also used. To protect the scenery, subway station signs and other prominent manmade objects are not installed near historical sites such as the Arc de Triomphe, the Paris National Opera, the Louvre or the Place de la Concorde but tactile ground surface indicators, in colors that stand out (white and yellow), are an exception (Fig. 6)

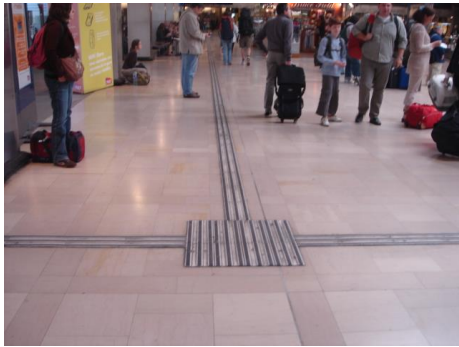
Fig. 7: Tactile Ground Surface Indicators at Montparnasse Station (Paris, France)

Paris has recently been emphasizing barrier-free accessibility, including such experimental efforts as the uniquely configured blocks installed at the Montparnasse rail station (Fig. 7).

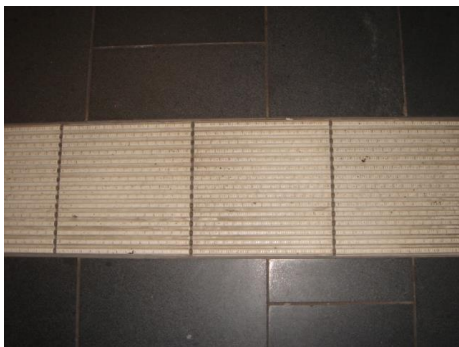
Fig. 8: Directional Blocks Used at Rail Stations (Frankfurt, Germany)

In Frankfurt, blocks are installed inside rail and subway stations and on the platforms at rail, subway and tram stations. Many blocks are white, although some are grey. The warning blocks inside rail stations are of similar configuration to those used in Japan. The directional blocks used at train stations and the blocks used at subway and tram stations are uniquely German in configuration. Directional blocks at train stations are made up of thin linear protrusions (Fig. 8). Directional blocks are installed at rail station platforms but no warning blocks—only non-slip strips with small dot-shaped protrusions located at the edge of the platform. Tram stations use the same directional blocks as at rail stations but warning blocks are never used at platform edges or where blocks intersect (Fig. 9).

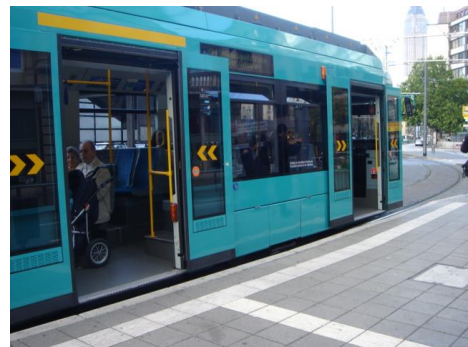
Fig. 9: Tactile Ground Surface Indicators at Tram Station (Frankfurt, Germany)

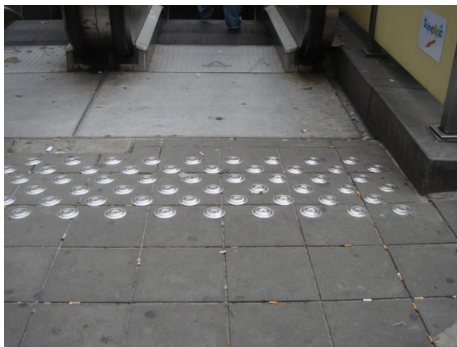
Fig. 10: Metal Disks Used in Belgium  
(Brussels, Belgium)

One of the Belgium-specific blocks uses metal disks of roughly 85mm in diameter and 8mm in height (Fig. 10). In Japan, the prescribed size of warning block protrusions is 22mm in diameter ( $\pm 1.5\text{mm}$ ) and 5mm in height, a size designed to promote mobility by the visually impaired without impeding the movement of wheelchair users or elderly pedestrians. Given the large size, height and slipperiness of the metal disks used in the Belgian blocks, one suspects that they present a significant obstacle for wheelchair users, children and the elderly.

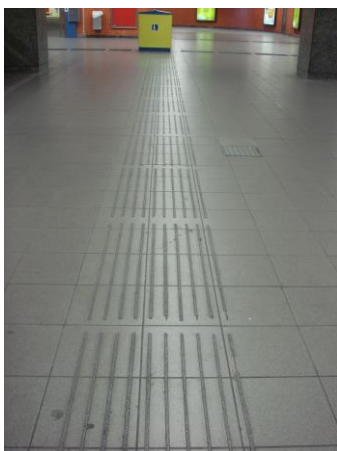
Fig. 12: Embedded Directional Metal Bars  
(Brussels, Belgium)

In one part of the city, metal bars are embedded in the road surface where one would expect to find warning blocks (at the top of stairs and escalators, for example) (Fig. 11). Being only 3mm in height, these protrusions create no obstacle for wheelchair users or elderly pedestrians but also seem likely to go unnoticed by the visually impaired. In some places, similar metal bars are embedded in the road surface and serve a directional function (Fig. 12). Rubber warning blocks are also sometimes installed at bus stops where directional blocks intersect (Fig. 13).

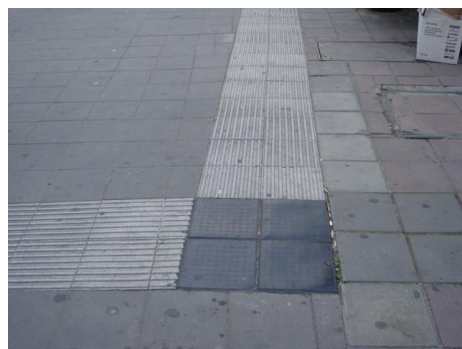
Fig. 13: Rubber Warning Blocks Where  
Directional Blocks Intersect  
(Brussels, Belgium)

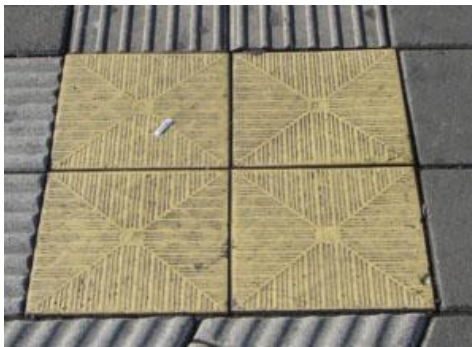
Fig. 14: Netherlands-Style Warning Blocks  
(Amsterdam, Netherlands)

Netherlands-specific blocks include some with thin recessed lines as in Fig. 14. With very little surface irregularity, such blocks are extremely difficult to detect with the feet or a white cane. Grooves carved into the pavement at subway station platforms (Fig. 15) are also difficult for people with impaired vision to recognize.

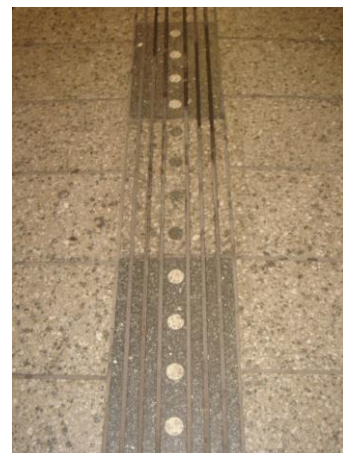
Fig. 15: Grooves Carved into the  
Pavement (Amsterdam,  
Netherlands)

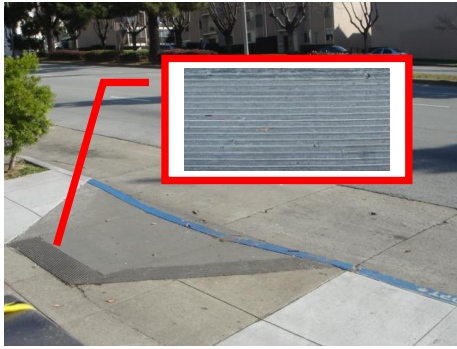
Fig.16: Shallow Grooves Cut into the Pavement before a Crosswalk (San Francisco, USA)

California uses distinctive landmarks to help the visually impaired cross the road safely (Fig. 16). Rather than lay down tactile ground surface indicators before crosswalks, shallow grooves are cut into the pavement. These are more difficult to detect than tactile ground surface indicators when using feet or a cane. This installation method is uniform in San Francisco, Los Angeles and San Diego.

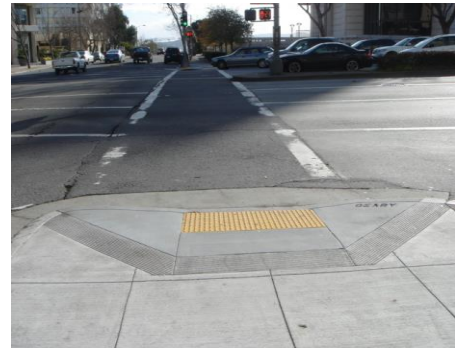
Fig. 17: Tactile Ground Surface Indicators before a Crosswalk (San Francisco, USA)

Although the number of locations is not large, warning blocks like those in Japan are also used before crosswalks, at rail and subway stations and at tram platforms. Directional blocks are also installed at rail station platforms. Blocks are yellow, black or white. Installations of blocks before crosswalks (Fig. 17) appear arbitrary, lacking consistent rules.

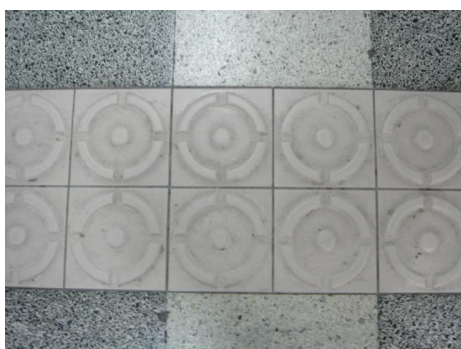
Fig. 19: Blocks Used in Some Seoul Subway Stations (Seoul, Korea)

In Korea, warning blocks and directional blocks are installed in accordance with Japanese rules in many locations including sidewalks, subway and rail stations and platforms, public facilities and large shopping centers. The configuration of the blocks, with the exception of some subway stations in Seoul (Fig. 19), is the same. Blocks are yellow, silver, brown, white and grey. Because installation methods are adopted whole cloth from Japan, many of the same errors are found.

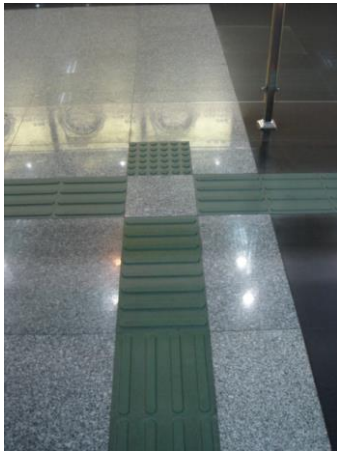
Fig. 20: No Blocks Used Where Directional Blocks Intersect (Guangzhou, China)

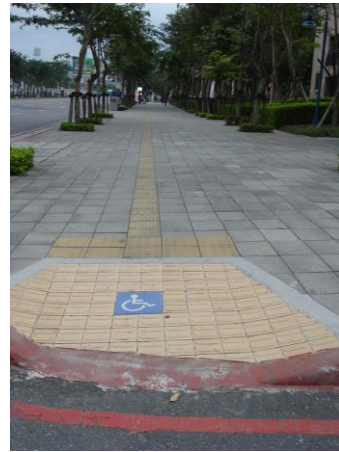
Fig. 21: Blocks Installed Across the Sloped Area before a Crosswalk (Taipei, Taiwan)

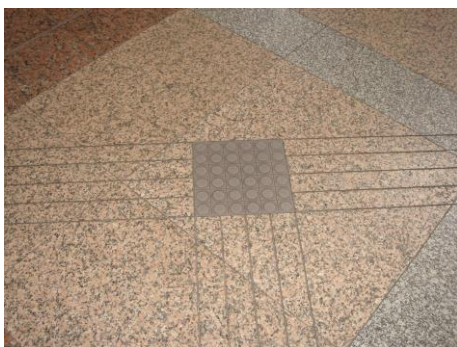
Fig. 22: Directional Indicators Carved Into the Pavement (Kuala Lumpur, Malaysia)

In Kuala Lumpur, blocks are installed mainly at rail, subway, LRT and monorail stations and the surrounding sidewalks. In some locations warning and directional blocks are installed as in Japan while in other locations directional indicators are carved into the pavement and warning blocks are installed where directional markers intersect and where pedestrians are to stop (Fig. 22). The latter practice is often followed at rail and LRT stations but the two types were found to coexist at one location. Blocks are yellow, silver and grey.

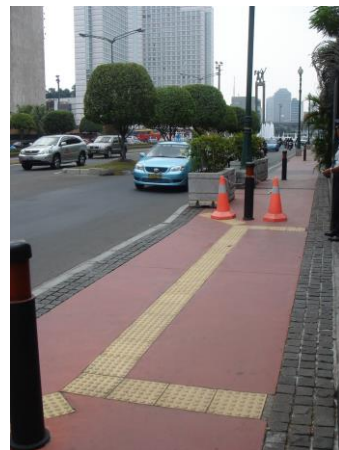
Fig. 23: Tactile Ground Surface Indicators Used to Indicate Parking Lot Entrances (Jakarta, Indonesia)

Warning blocks indicating the entrance to parking lots are installed on the sidewalks in Jakarta's Jalan Thamrin business area as shown in Fig. 23, an installation method unique to Indonesia. Blocks of this type are installed at nearly every parking lot entrance, making for a great many installations. Warning blocks are also installed before some crosswalks in the Jalan Thamrin area. No blocks are installed outside this area, however. Blocks are yellow in color.

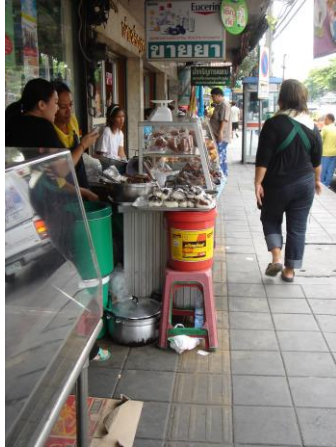
Fig. 24: Sidewalk Vendors Covering Blocks  
(Bangkok, Thailand)

Warning and directional blocks are used on many sidewalks in central Bangkok. Warning blocks are also installed at the top and bottom of stairways at subway and monorail stations. Blocks are not, however, installed at rail stations or rail platforms. Installation rules are roughly the same as in Japan. Blocks are yellow or grey. Many damaged blocks seem to be left unrepaired. Bangkok is a city with many vendors who set up shop on sidewalks; these frequently end up covering the blocks (Fig. 24).

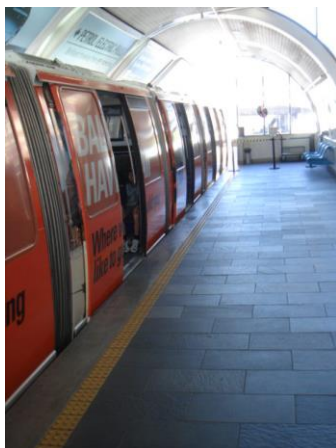
Fig. 25: Use of Narrow (15cm Wide) Warning  
Blocks (Sydney, Australia)

Examples of narrow warning blocks were observed in the UK, Australia, Korea and Taiwan. Such installations at station platforms, as in Fig. 25, can lead a person with impaired vision to fall onto the track.

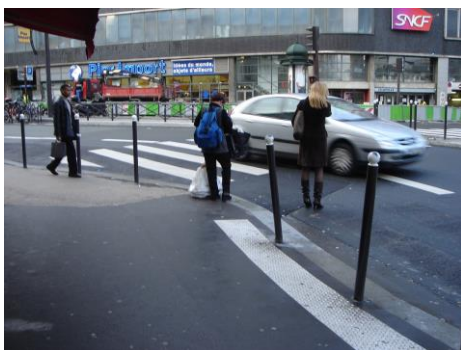
Fig. 26: Incorrect Positioning at the Entrance to a Crosswalk (Paris, France)

Examples of warning blocks positioned too far from obstacles were observed in the USA, Australia, Korea, Taiwan and Hong Kong. Examples of blocks positioned too close to obstacles were found in Korea and China. Examples of incorrect positioning of blocks at the entrance to crosswalks or doors were found in France, the USA, Australia, Korea and Taiwan (Fig. 26). Such errors are the result of failing, when modifying the location of a crosswalk, to change the location of the blocks, instead leaving them where they were.

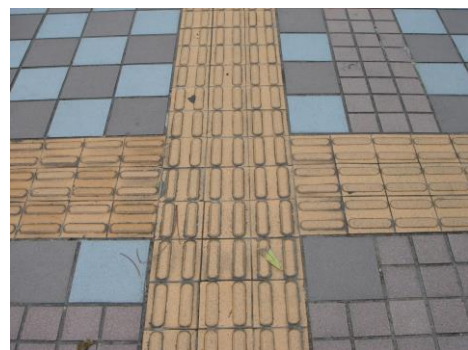
Fig. 27: Failure to Install Warning Blocks Where Directional Blocks Intersect (Taipei, Taiwan)

Examples of failing to install warning blocks where directional blocks intersect, as in Fig. 27, were observed in Korea, China, Taiwan, Malaysia and Thailand. Such installations can lead a person with impaired vision to become lost by preventing detection of a turning point

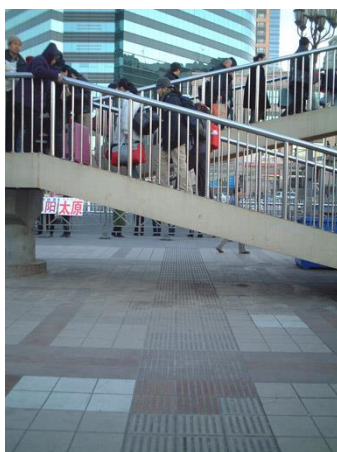
Fig. 28: Pedestrian Bridge Located above Tactile Ground Surface Indicators (Beijing, China)

Examples of obstacles above or near directional blocks (other than items such as bicycles or motorcycles that can be moved) were observed in Germany, Korea, China, Malaysia and Thailand. Because objects located above waist level cannot be detected with a white cane<sup>6</sup>, in a situation like the one illustrated in Fig. 28 a person with impaired vision could fail to notice the pedestrian bridge and crash into it, suffering serious injury.

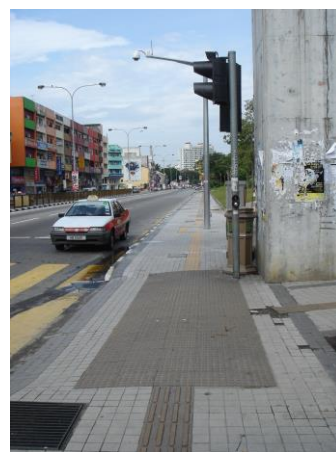
Fig. 29: Installation of an Excessive Number of Blocks (Kuala Lumpur, Malaysia)

Examples of installations with an excessive number of blocks were observed in the UK, Korea, Taiwan, Singapore, Malaysia and Thailand. Installations before crosswalks like the one illustrated in Fig. 29 not only obscure the entrance to the crosswalk but also make it difficult to identify the direction of the crosswalk, leading to the danger that a person with impaired vision might step out in the wrong direction, perhaps toward the middle of the intersection. Such installations create obstacles not only for the visually impaired but also for the elderly and for those using wheelchairs or strollers.

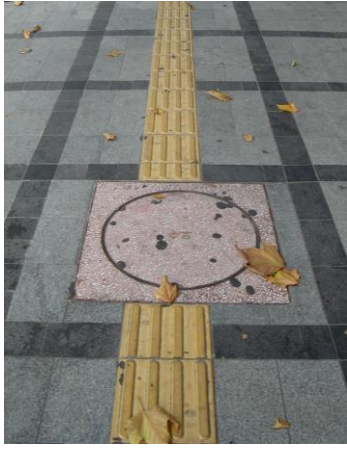
Fig. 30: Directional Blocks Interrupted by Manhole Cover (Seoul, Korea)

Examples of blocks interrupted by objects such as manhole covers (Fig. 30) were observed in all countries that installed blocks except the USA and Singapore, where there are few block installations and no such examples could be found during the current survey. Interrupted blocks mean confusion for people with impaired vision, who lose their directional guide. There is a need to communicate to the world the importance of installing blocks even on manhole covers.

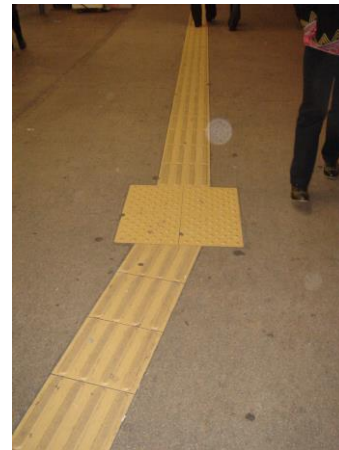
Fig. 31: Installation of Warning Blocks Where They are Unnecessary (Hong Kong)

Examples of warning blocks installed in places where they are unnecessary were found in Korea, China, Taiwan and Hong Kong. As in Fig. 31, warning blocks were frequently installed in situations where there was a slight change in the direction of directional blocks. Warning blocks cause people with impaired vision to stop and attempt to identify what danger their attention is being drawn toward. Unnecessary warning blocks greatly reduce walking efficiency.

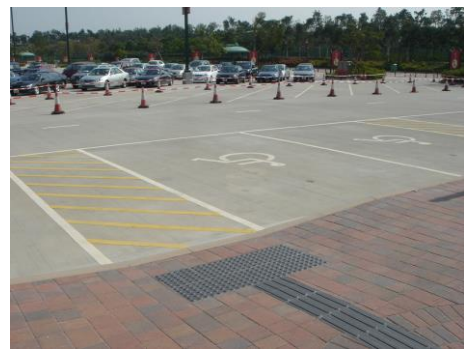
Fig. 33: Tactile Ground Surface Indicators Installed at Disabled Parking Spaces (Hong Kong)

Examples of installations at disabled parking spaces were observed in the USA and Hong Kong (Fig. 33). People with impaired vision do not use such parking spaces by themselves so blocks that impede the movement of wheelchair users should not be installed.

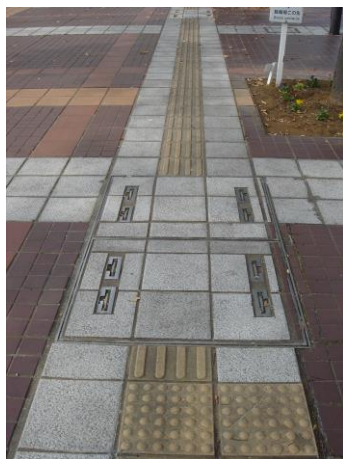
Fig. 34: As in this instance, manhole covers often interrupt the flow of directional blocks, causing people with impaired vision to lose track of which direction they should proceed. (Tokyo, Japan)

Improved Version: As illustrated here, manhole covers should be outfitted with Tactile ground surface indicators.

Directional blocks must be installed in succession or people with impaired vision will be required to search for the next block using their canes, greatly reducing their walking efficiency. Manhole covers are one cause of such discontinuity and should generally be outfitted with Tactile ground Surface Indicators.

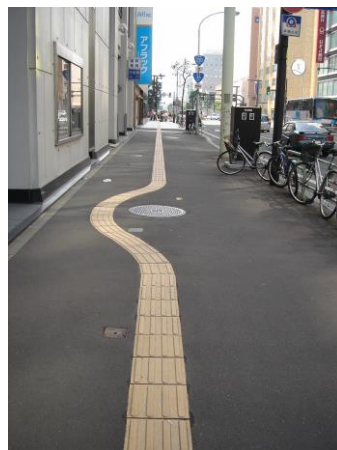
Fig. 36: Rerouting directional blocks to avoid the manhole, as in this photograph, not only looks unattractive but creates a winding course that greatly reduces the walking speed of people with impaired vision. (Hokkaido, Japan)

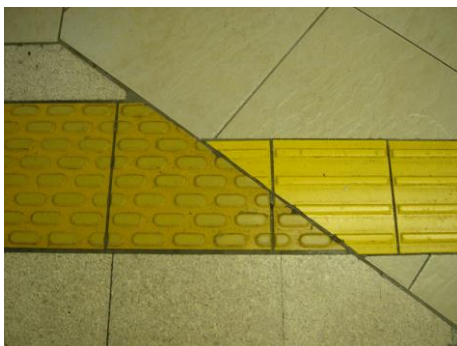
Fig. 38: The situation depicted here is the result of different organizations having jurisdiction over the areas to the left and the right. Both types of blocks are directional blocks but the ones on the left with raised ovals can easily be mistaken for warning blocks with raised dots. The likelihood of misreading the blocks is particularly high when walking from the right to the left. (Tokyo, Japan)

The size, shape and color of blocks often varies with jurisdictional differences between the facilities or roadways where they are installed. Although the selection of Tactile ground surface indicators must take ground surface condition and tile variations into account, uniform blocks should be used continuously wherever possible for the convenience of people with impaired vision and to maintain an attractive environment.

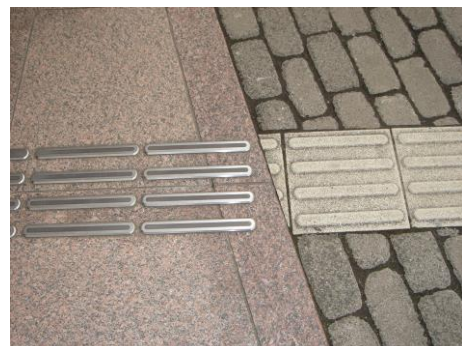
Fig. 39: Situations such as this one, where both shape and materials differ, make it difficult for people with impaired vision to walk and are also unattractive. (Tokyo, Japan)

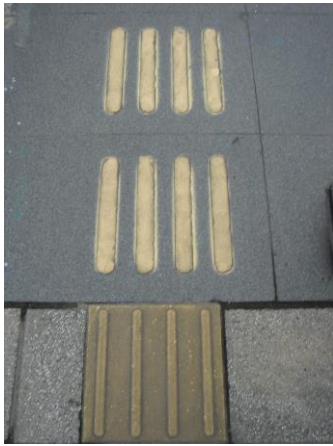
Fig. 40: Many examples of similar errors can also be found overseas. (Taipei, Taiwan)

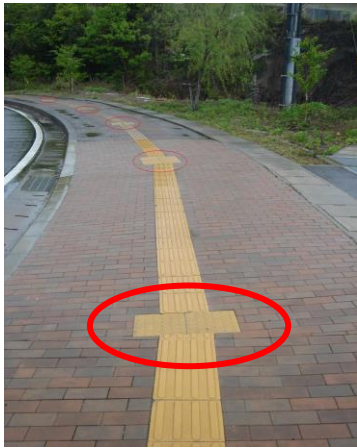
Fig. 42: Installing warning blocks at shallow bends such as these means people with impaired vision must frequently come to a stop. (Nagasaki, Japan)

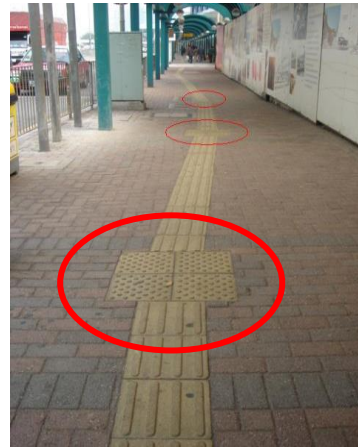
Fig. 43: Many similar examples of the overuse of warning blocks can also be found overseas. (Hong Kong)

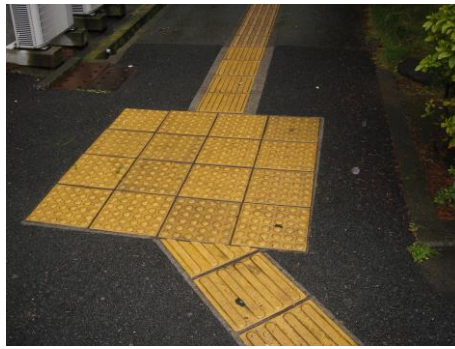
Fig. 45: This is an example of an excessive number of warning blocks installed at a bend in a line of directional blocks. Such a large number of blocks requires people with impaired vision to spend time searching about and can result in their losing track of which direction to proceed. The number of warning blocks should be reduced as in the improved version. (Kanagawa, Japan)

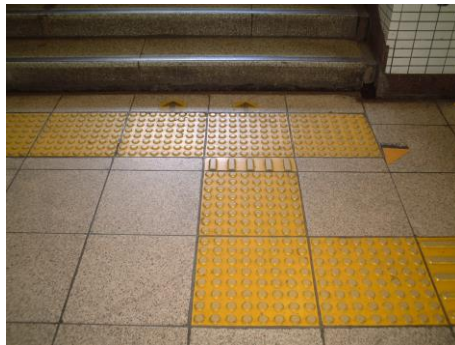
Fig. 47: In a narrow corridor where blocks must be arranged in an L-shape, one warning block should be installed at the bend in the L with directional blocks above and to the right as illustrated in the improved version here. (Tokyo, Japan)

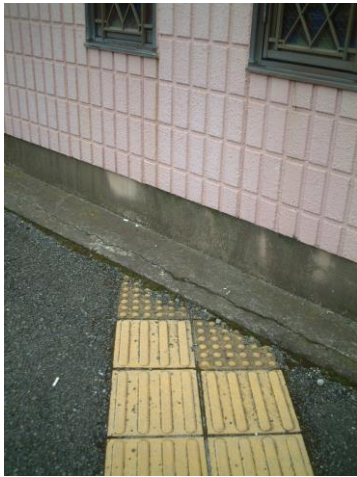
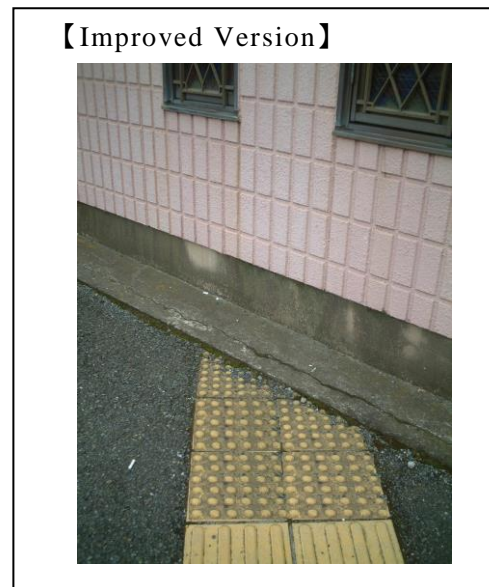
Fig. 48: Because of the small area covered by the warning blocks installed before the wall, people with impaired vision will run into the wall before noticing the warning blocks. (Kanagawa, Japan)

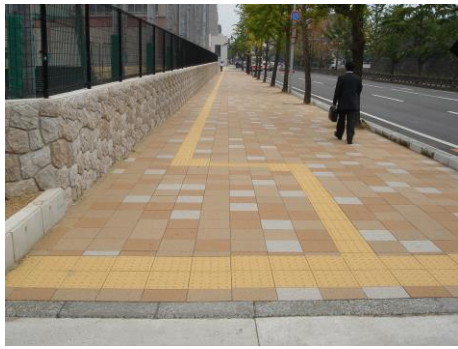
Fig. 50: This is an example of an unnecessary bend in a directional block installation preceding a crosswalk. The directional blocks should simply continue straight ahead as in the improved version. (Wakayama, Japan)

Directional blocks should be installed in straight lines, avoiding bends wherever possible. Warning blocks can be installed at bends but these require people with impaired vision to come to a stop and take time searching out which direction to proceed. Installation routes should be planned to avoid unnecessary bends.

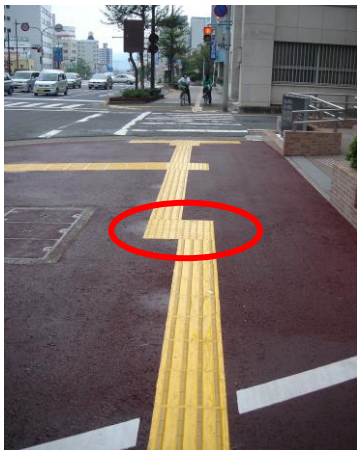
Fig. 51: Here, warning blocks have been installed where the row of directional blocks was shifted over to the left by the width of one block (30cm) before a crosswalk to align the directional blocks with the center of the crosswalk. As long as the directional blocks leading to a crosswalk are not too close to the crosswalk's edge, there is no need to install warning blocks and alter the course of the directional blocks in this way. (Hokkaido, Japan)

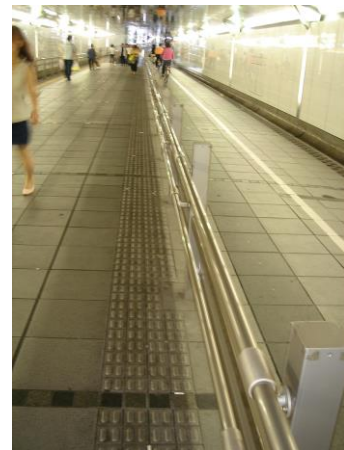
Fig. 52: Directional blocks should not be installed at the edge of walkways because some people with impaired vision, rather than walking directly on top of Tactile ground surface indicators, walk to the side while sensing the texture of the blocks with their canes. This is why it is necessary to leave 30cm open on either side of the directional blocks. Here, the guardrail immediately adjacent to the directional blocks is likely to be an impediment to walking. (Ciba, Japan)

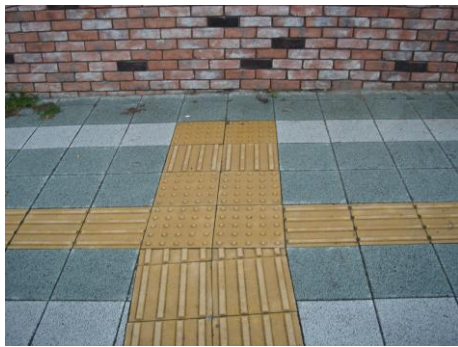
Fig. 53: Here, a single row of directional blocks leads to the wall followed by warning blocks signaling the end of the line. These blocks are unnecessary. As in the improved version, the warning blocks signaling the intersection alone are sufficient. (Wakayama, Japan)

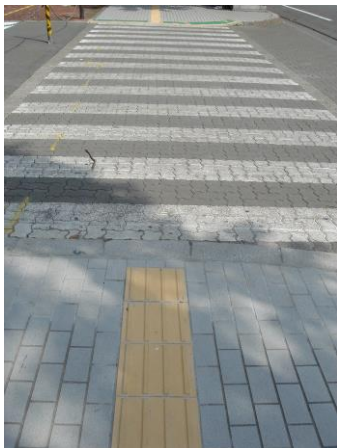
Fig. 54: Situations like this one are extremely dangerous as people with impaired vision, rather than stopping before the crosswalk, will step out into traffic as they search for the continuation of the line of directional blocks. Warning blocks should be installed as in the improved version. (Hokkaido, Japan)

Crossing the road is said to be one of the most stressful situations for people with impaired vision. In general, two rows of warning blocks should be installed before crosswalks to bring users to a stop.

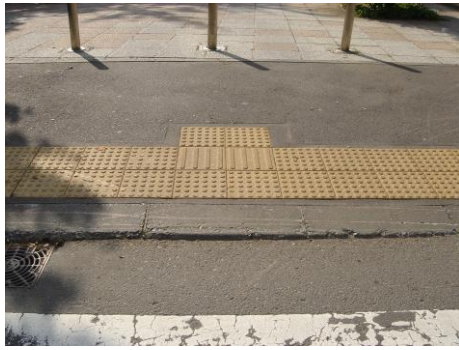
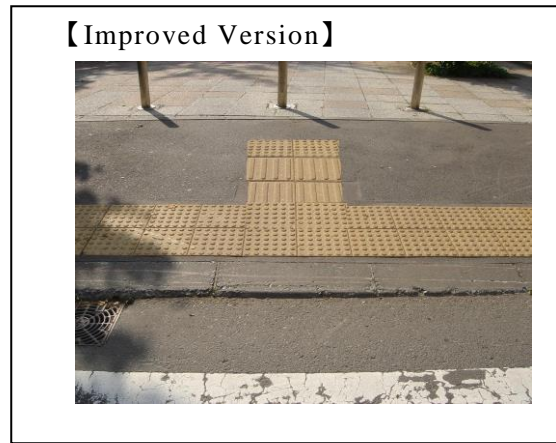
Fig. 55: It is ordinarily best to install two rows of warning blocks before a crosswalk. Where directional blocks are followed by only a single row of warning blocks, as shown here, people with impaired vision may either fail to notice the warning blocks and walk out into the road or inadvertently step over the warning blocks and come to a stop after stepping out into the road. Two rows of warning blocks should be installed as in the improved version. (Hokkaido, Japan)

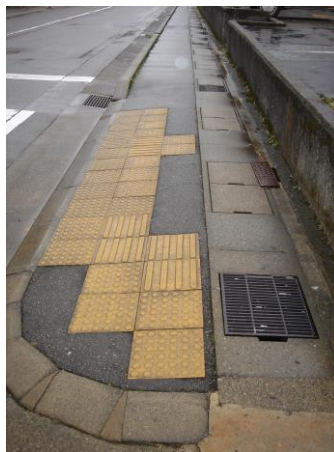
Fig.56: On narrow sidewalks like this, one sometimes sees installations where many Tactile ground surface indicators are used to mark crosswalks leading in two directions, making it difficult for people with impaired vision to determine where the blocks lead and what they are meant to warn them of. In situations like this, despite the general rule of using two rows of warning blocks before crosswalks, the number of blocks should be adjusted as needed to prioritize ease of identification by users. The improved version makes it easier to determine the position and orientation of the crosswalks by using single rows of warning blocks that are installed to completely cover the edges of the sidewalk. (Ishikawa, Japan)

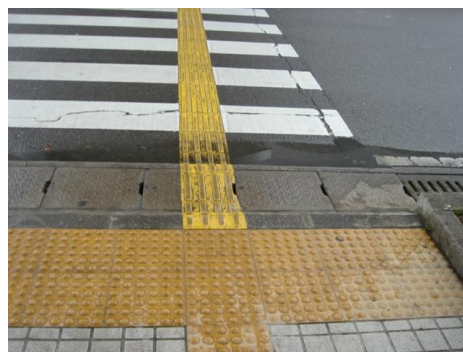
Fig. 57: Directional blocks are increasingly installed within crosswalks, something extremely effective for people with impaired vision. When crossing the road, people with impaired vision try to be particularly careful not to proceed in the wrong direction. Should they stray greatly from the intended path they may be unable to reach the far side of the road and instead stray into the road. However, using blocks of the same shape as ordinary directional blocks, as in this example, is dangerous because users may not realize they are in a crosswalk. Specially shaped blocks such as those shown in Fig. 58 should be used in crosswalks. (Miyazaki, Japan)

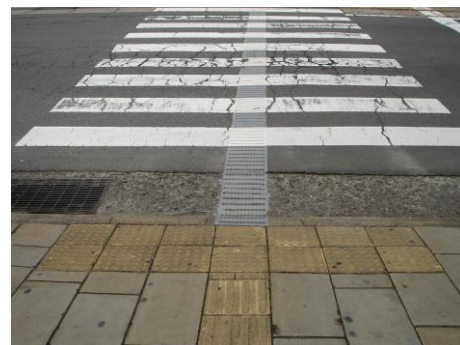
Fig. 59: An example of a crosswalk with escort zone.

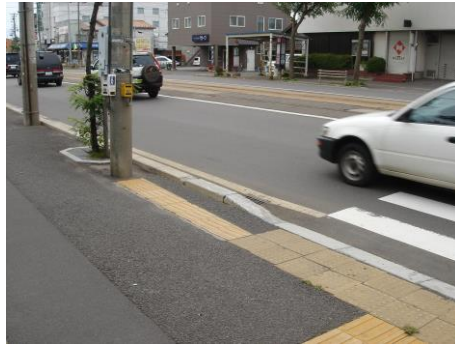
Fig. 60: Many crosswalks are outfitted with pushbutton-operated signals for pedestrians. In this case, a pushbutton accessible to people with disabilities has been installed. Installations of directional blocks leading to such pushbuttons are rarely seen, yet are helpful in enabling people with impaired vision locate the pushbuttons. (Hokkaido, Japan)

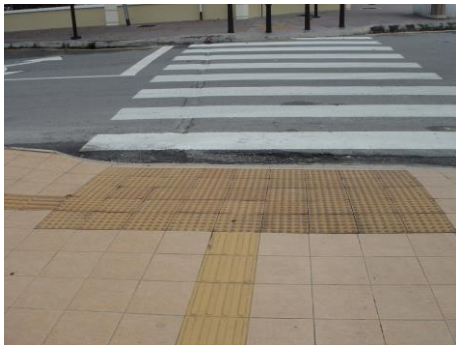
Fig. 61: Examples of numerous Tactile ground surface indicators installed before crosswalks, which can cause people with impaired vision to lose their way, are often seen overseas as well as in Japan. (Kuala Lumpur, Malaysia)

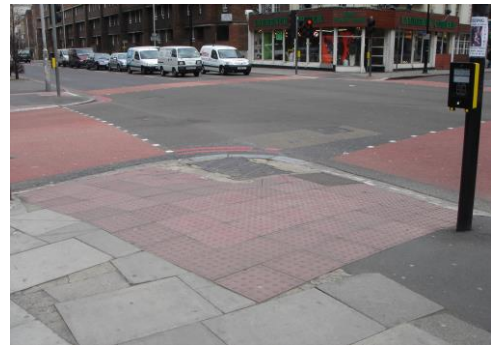
Fig. 62: Covering the sidewalk with blocks as in this example makes it impossible for users to determine where the crosswalks are or which direction to proceed. (London, UK)

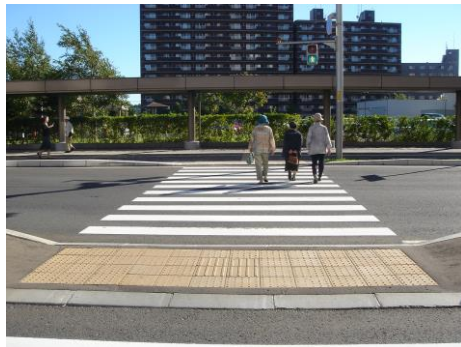
Fig. 63: Wide medians like this one can cause people with impaired vision to mistakenly think they have crossed the road, so blocks need to be installed in accordance with the proper rules. Blocks installed over the entire surface, as is the case here, are cause for user confusion. Accordingly, installations should be consistent in using double rows of warning blocks at either end of the crosswalk and single rows of warning blocks on either side of the median. (Hokkaido, Japan)

Examples of installation at medians were observed in the UK, the Netherlands and Hong Kong. Blocks at medians can lead people with impaired vision to mistakenly believe they have passed through the crosswalk and begin to walk along the median<sup>7</sup>.

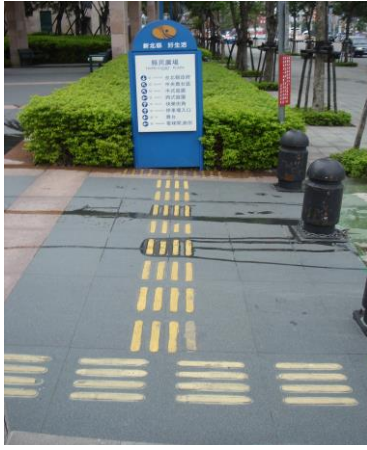
Fig. 66: Similar errors are also common overseas. (Taipei, Taiwan)

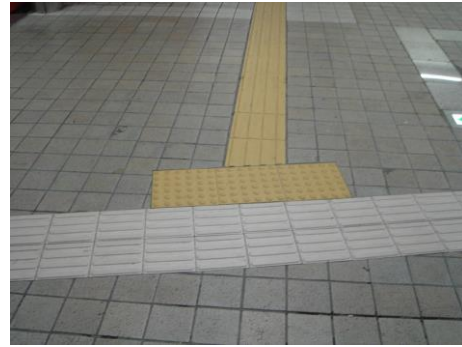
Fig. 67: Warning blocks are sometimes installed in this manner at T-shaped intersections, but such warning blocks will go unnoticed by people with impaired vision who are moving along the path composed of white directional blocks. (Seoul, Korea)

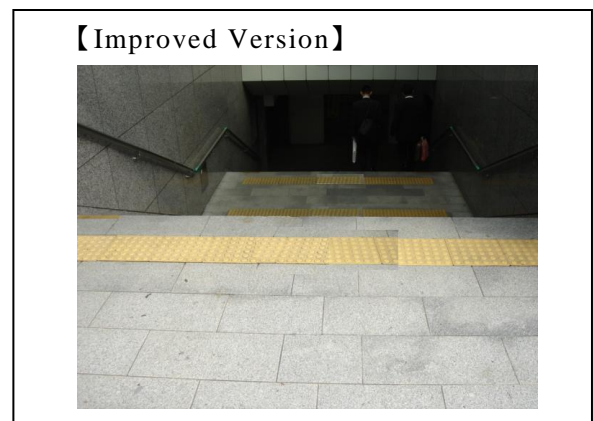
Fig. 68: Here, the line of warning blocks installed at the top of the stairs is truncated. A person with impaired vision arriving at the open gap would fail to come to a stop as there are no warning blocks. There is a real danger of falling down the stairs. The line of warning blocks should be continuous as in the improved version. (Toyama, Japan)

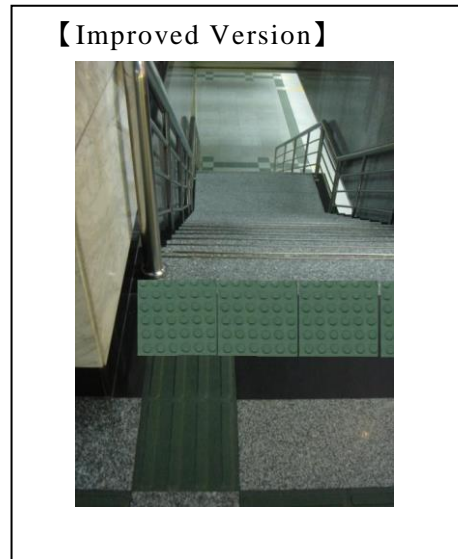
Fig. 69: Here there are no warning blocks at the top of the stairs. Unable to stop, people with impaired vision may fall down the stairs. (Guangzhou, China)

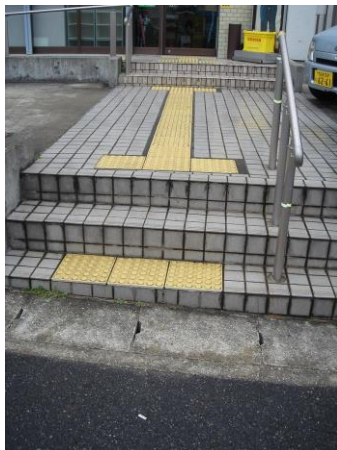
Fig. 70: Warning blocks should generally be installed at the top of stairways and on the ground or floor following the final step. Here, the warning blocks at the bottom of the stairs have been installed not on the ground level but on the final step. People with impaired vision coming down the stairs will sense the warning blocks and determine that they have reached ground level. Because in fact they have an additional step to go, this may lead to accidents such as falls or twisted ankles. Warning blocks should be repositioned as in the improved version. (Aichi, Japan)

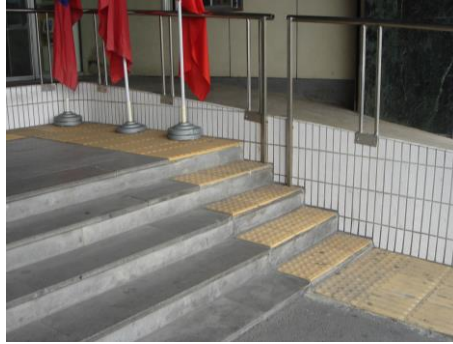
Fig. 71: Warning blocks are sometimes installed on each step of a stairway. Such warning blocks are unnecessary. (Taipei, Taiwan)

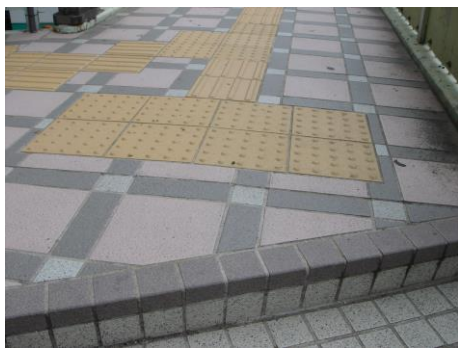
Fig. 72: Here, warning blocks have been installed in a way that is neither adjacent nor parallel to the edge of the stairs. (Nagasaki, Japan)

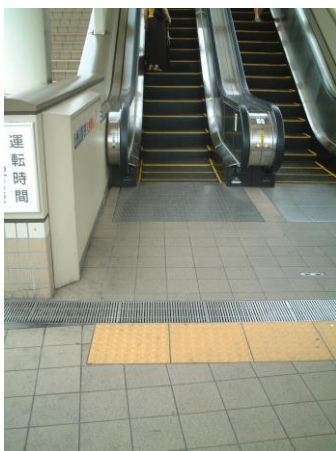
Fig. 76: Here the warning blocks are located too far from the entrance to the escalator, and should instead be installed as in the improved version. (Tokyo, Japan)

Warning blocks should be installed close to the entrances to escalators.

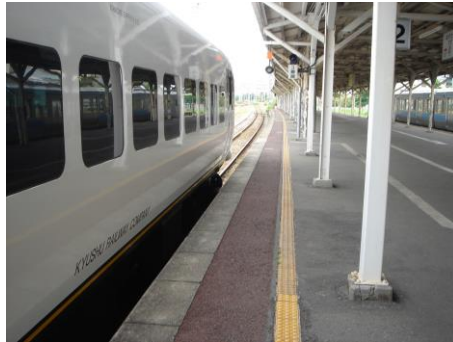
Fig. 77: Here the warning blocks measure only 15cm wide. There is the risk that people with impaired vision may inadvertently step over the blocks and fall onto the tracks. Warning blocks measuring 30cm square should be used on platforms. (Nagasaki, Japan)

Railway platforms are extremely dangerous locations for people with impaired vision. To prevent people from falling onto the tracks, it is customary to use warning blocks along platform edges. It is best if such warning blocks measure the JIS standard 30cm square.

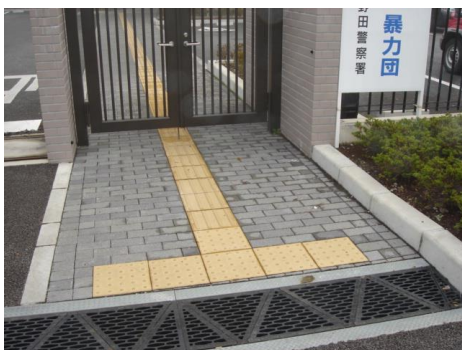
Fig. 78: Warning blocks should be installed before gates. (Chiba, Japan)

Warning blocks should be installed before gates and doors to make their presence known. Otherwise, people with impaired vision may run into them when they are opened.

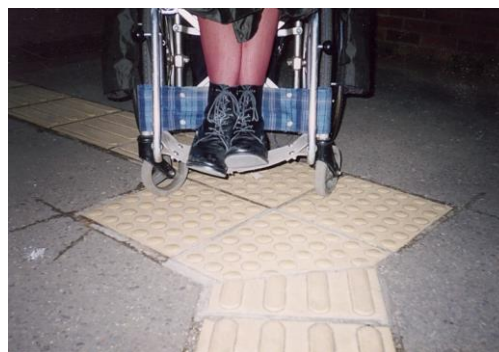
Fig. 80: As depicted here, the protrusions on Tactile ground surface indicators can cause wheelchair wheels to change direction, making it difficult to move forward.

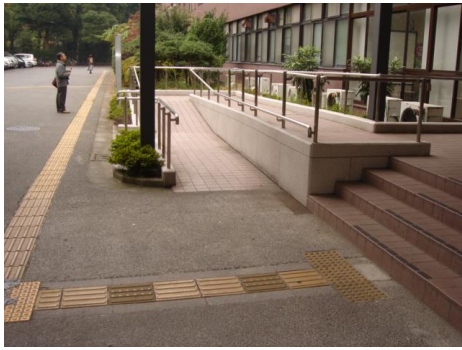
Fig. 81: As shown here, directing people with impaired vision to use the stairs instead of installing Tactile ground surface indicators on the slope eliminates the problem of inconvenience for wheelchair users. (Tokyo, Japan)

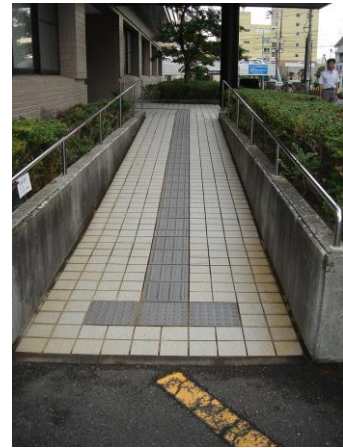
Fig. 82: Installing blocks on a slope as in this example is not appropriate. (Miyazaki, Japan)

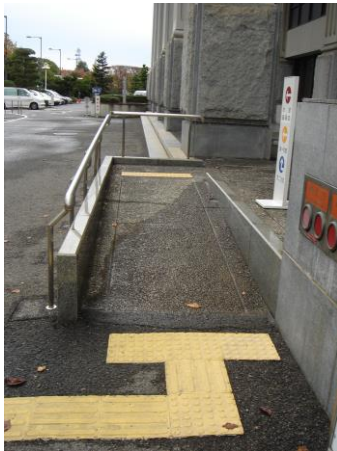
Fig. 83: Blocks are often installed at the beginning and end of slopes, but this creates a barrier for wheelchair users. (Ehime, Japan)

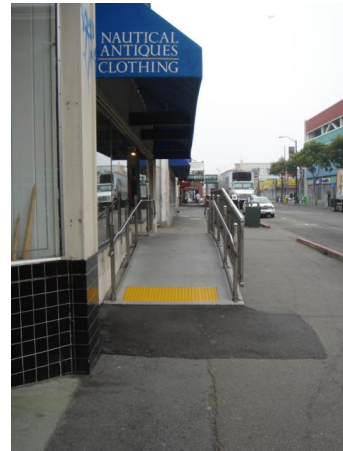
Fig. 84: Similar errors are also common overseas. (San Francisco, USA)

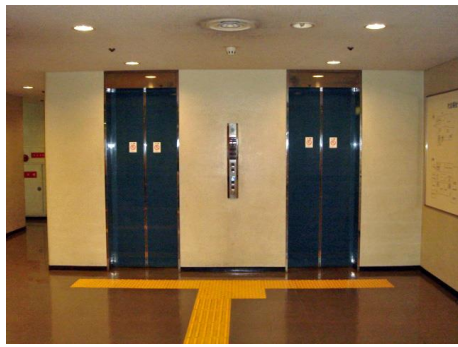
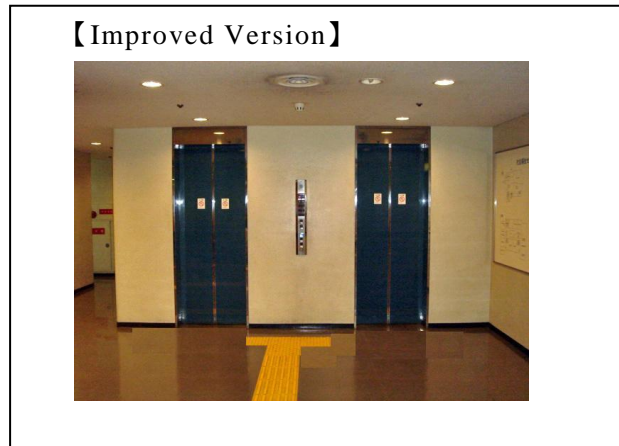
Fig. 85: Tactile ground surface indicators installed in this way create a barrier for wheelchair users. Blocks should instead be installed only before the call buttons as shown in the improved version. (Osaka, Japan)

Tactile ground surface indicators installed in front of elevator entrances can cause wheelchair wheels to catch. Therefore, care must be taken to minimize the barrier to wheelchair use by installing Tactile ground surface indicators only before the call buttons rather than across the entire width of the elevator entrance.

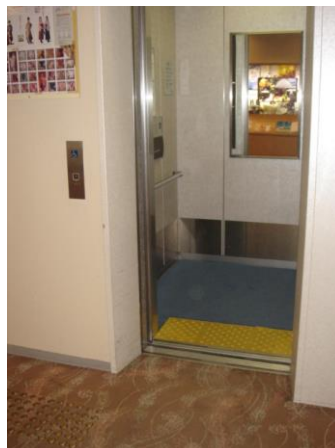
Fig. 86: Warning blocks are sometimes installed inside elevators. People with impaired vision, however, will not lose track of the entrance within the narrow confines of an elevator. Such blocks are an obstacle to wheelchair use and should be removed. (Ehime, Japan)

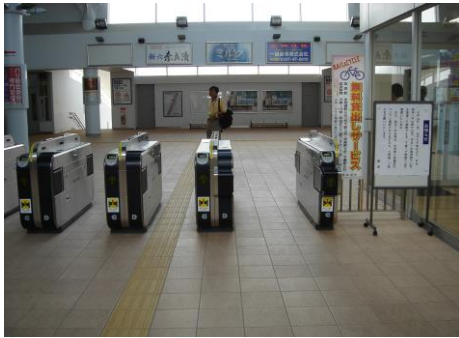
Fig. 87: Here, the wicket where Tactile ground surface indicators are installed is correctly separate from the wider wicket for wheelchair users. ( Ibaraki, Japan)

One often sees Tactile ground surface indicators installed at the wide wickets designed to facilitate passage by wheelchair users. Such blocks, however, are an obstacle to wheelchair use. Since there is no need for people with impaired vision to use the wider wickets, Tactile ground surface indicators should be installed at wickets separate from those designed for wheelchair users.

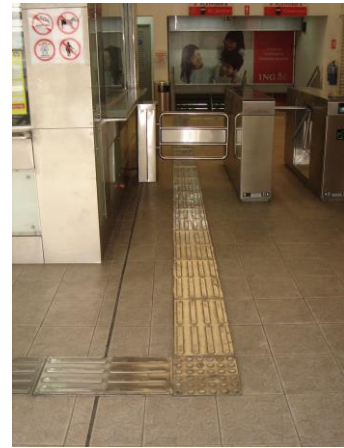
Fig. 88: In fact, there are many cases where Tactile ground surface indicators are installed at the wider, manned wickets. (Kuala Lumpur, Malaysia)

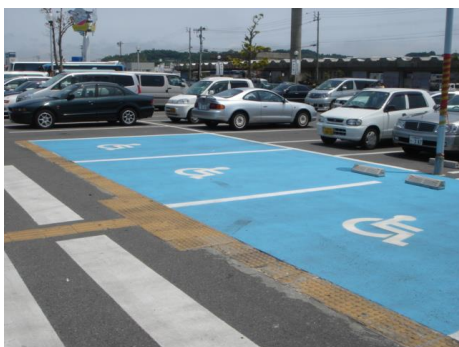
Fig. 89: Here, the extensive installation of Tactile ground surface indicators at disabled parking spaces creates a barrier for wheelchair users. ( Fukushima, Japan)

Disabled parking spaces are designed for wheelchair-using drivers who must open their doors fully when getting in and out of their cars. People with impaired vision will never use disabled parking spaces when alone. Blocks that create an obstacle for wheelchair users should not be installed at disabled parking spaces.

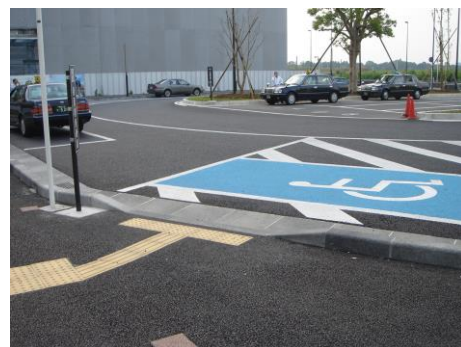
Fig. 90: Because disabled parking spaces are established primarily for wheelchair users, Tactile ground surface indicators should not be installed. ( Chiba, Japan)

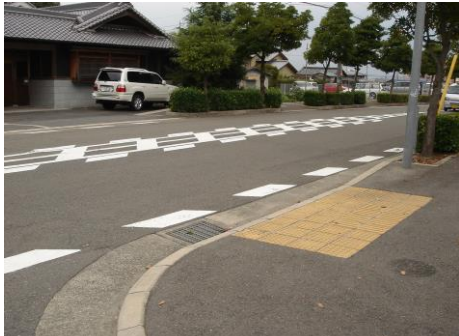
Fig. 91: Here the Tactile ground surface indicators have been left behind after the crosswalk that they marked was eliminated. There is a danger that people with impaired vision will mistakenly believe there to be a crosswalk and attempt to cross the road. (Osaka, Japan)

It goes without saying that when facilities or equipment to which Tactile ground surface indicators lead are moved, the position of the blocks should also be adjusted. Nevertheless Tactile ground surface indicators are often left in their original positions, creating confusing situations for people with impaired vision.

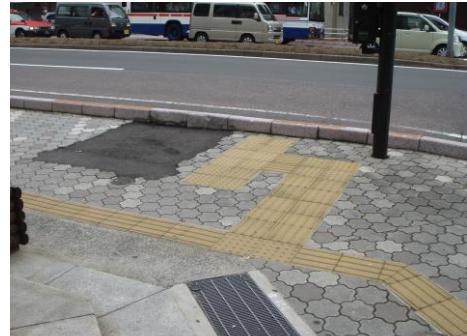
Fig. 92: The area filled in with black asphalt once contained some kind of equipment—probably a public telephone—yet the Tactile ground surface indicators were left as they were even after this equipment was removed. Such blocks should be adjusted when this kind of equipment is removed. (Nagasaki, Japan)

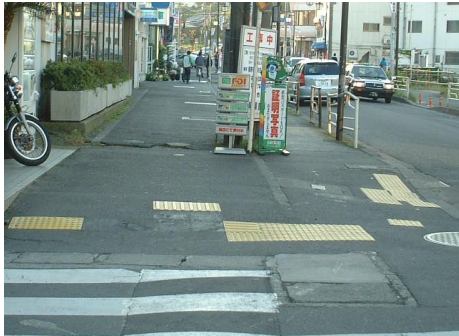
Fig. 94: Because the Tactile ground surface indicators have peeled away before the crosswalk, people with impaired vision may not recognize that there is a crosswalk and step out into the road. (Kanagawa, Japan)

One often sees cases where blocks have come loose or are broken and scattered about because regular maintenance has not been conducted after installation. This not only defeats the purpose of having Tactile ground surface indicators at all but also poses a tripping risk for pedestrians and looks terrible.

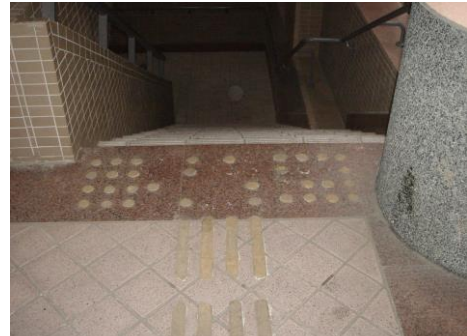
Fig. 95: Because the protrusions have disappeared from these warning blocks at the top of the stairs, people with impaired vision may not realize that there is a stairs and fall down. (Taipei, Taiwan)

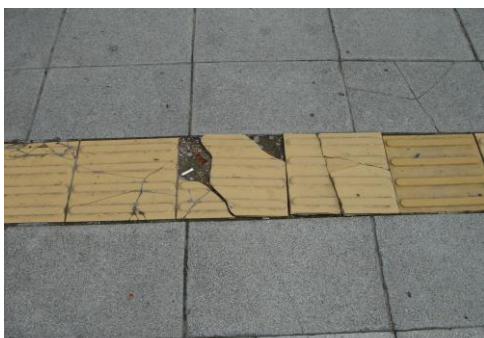
Fig. 96: An example of broken blocks left unattended. (Seoul, Korea)

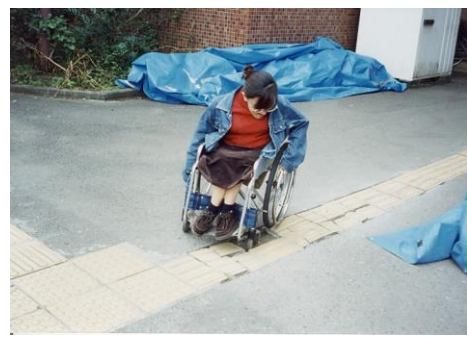
Fig. 97: Broken blocks not only pose a danger to people with impaired vision but are also a major barrier for wheelchair users.

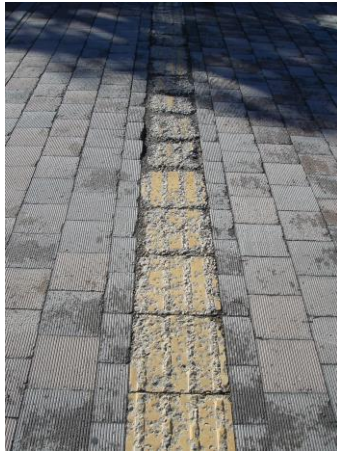
Fig. 98: In snowy areas, snow removal efforts often result in the loss of many protrusions. (Hokkaido, Japan)

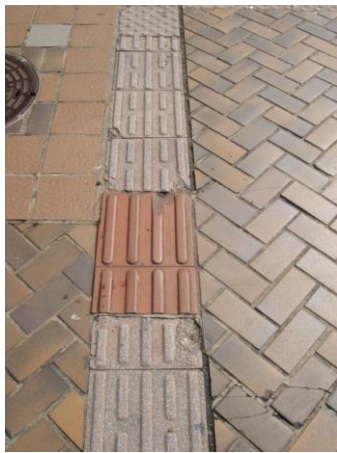
Fig. 99: The use of blocks different than those originally installed is common when Tactile ground surface indicators are repaired. The resulting mix of different specifications and shapes can lead to confusion among people with impaired vision. The loss of visual consistency is also unattractive. (Fukuoka, Japan)

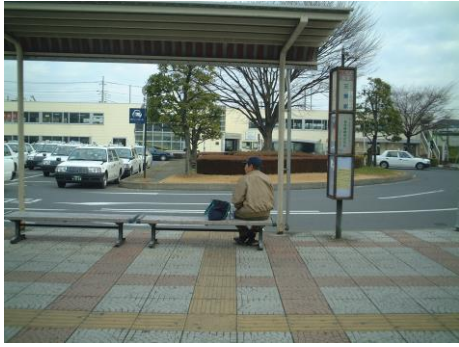
Fig. 101: One frequently sees benches placed above Tactile ground surface indicators at bus stops as shown here. Naturally, such obstructions should be avoided.

The lack of obstacles or dangers above them is a precondition for the installation of Tactile ground surface indicators. Nevertheless, one often sees signs or other obstacles positioned in the way. These obstacles interfere greatly with the movement of people with impaired vision.

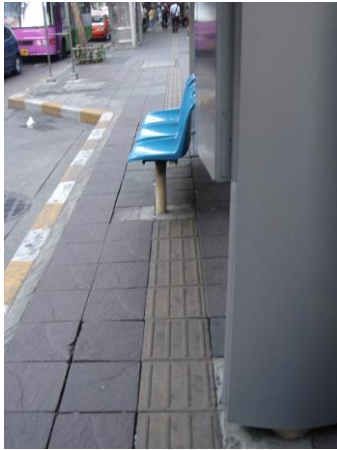
Fig. 102: Benches located above Tactile ground surface indicators at a bus stop in Thailand. (Bangkok, Thailand)

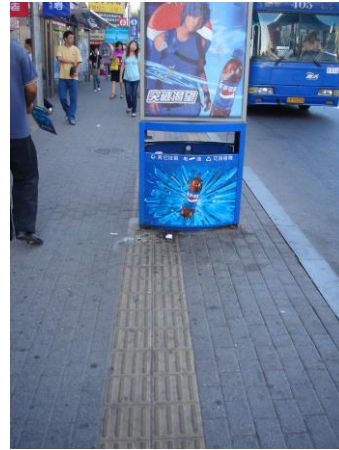
Fig. 103: A bus stop covering a line of directional blocks.

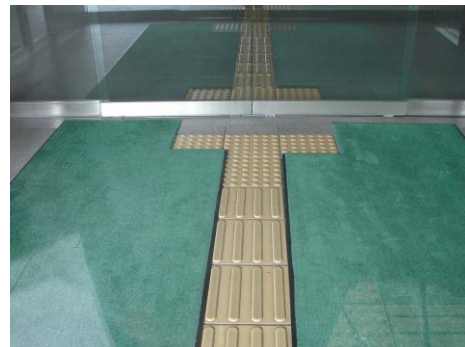
Fig. 105: Rather than cover the Tactile ground surface indicators with the mats, the mats should be shaped as shown to leave the blocks uncovered. (Hiroshima, Japan)

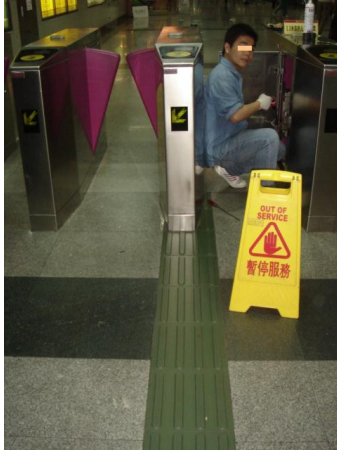
Fig. 106: An automated subway turnstile installed on top of a line of blocks. (Guangzhou, China)
