**Guidebook for the Proper Installation of Tactile  
Ground Surface Indicators (Braille Blocks):  
Common Installation Errors**

**International Association of Traffic and Safety Sciences**

**April / 2008**

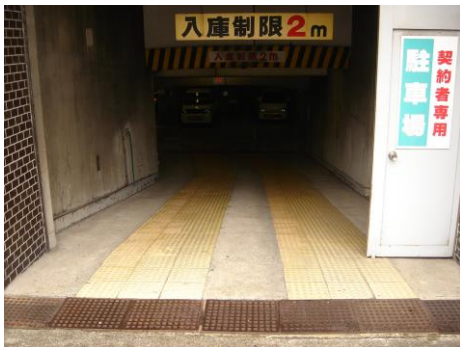
Fig. 107: Tactile ground surface indicators are sometimes used, as shown here, to create a non-slip surface at the entrances to underground parking areas. (Wakayama, Japan)

Tactile ground surface indicators are sometimes put to uses other than facilitating the safe movement of people with impaired vision. This can be a source of confusion for people with impaired vision and can even lead to serious accidents. Tactile ground surface indicators should only be used as originally intended.

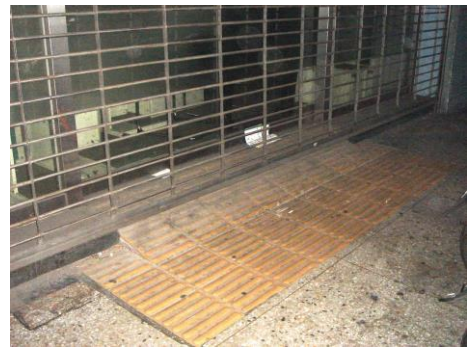
Fig. 108: Here, at the entrance to a store, Tactile ground surface indicators are used to create a non-slip surface as in Fig. 107. (Taipei, Taiwan)
