Creating installation guidelines for tactile ground surface indicators (braille blocks) for the visually impaired

1. Background and goals

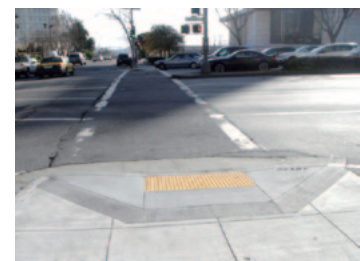
San Francisco, USA

Figure 2. Dissimilar braille blocks

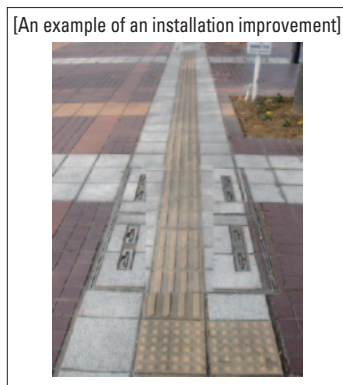
An example of an installation improvement given in the guidebook

Directional blocks must maintain continuity. Manholes are a common reason for interrupting the continuity of directional blocks. In such situations, directional blocks should also be installed on top of the manhole.
